Asbestos Management Survey Report:

Sittingbourne Adult Education Centre
College Road
Sittingbourne
Kent
ME10 1LF
United Kingdom

Date of survey:	Wednesday 16 th December 2015
Surveyors Name:	Robert Grover
Analyst / Quality Manager Name:	Phil Ogden
Signature:

Client:	Kent County Council Sessions House County Hall Maidstone Kent ME14 1XQ
Revision No.	001

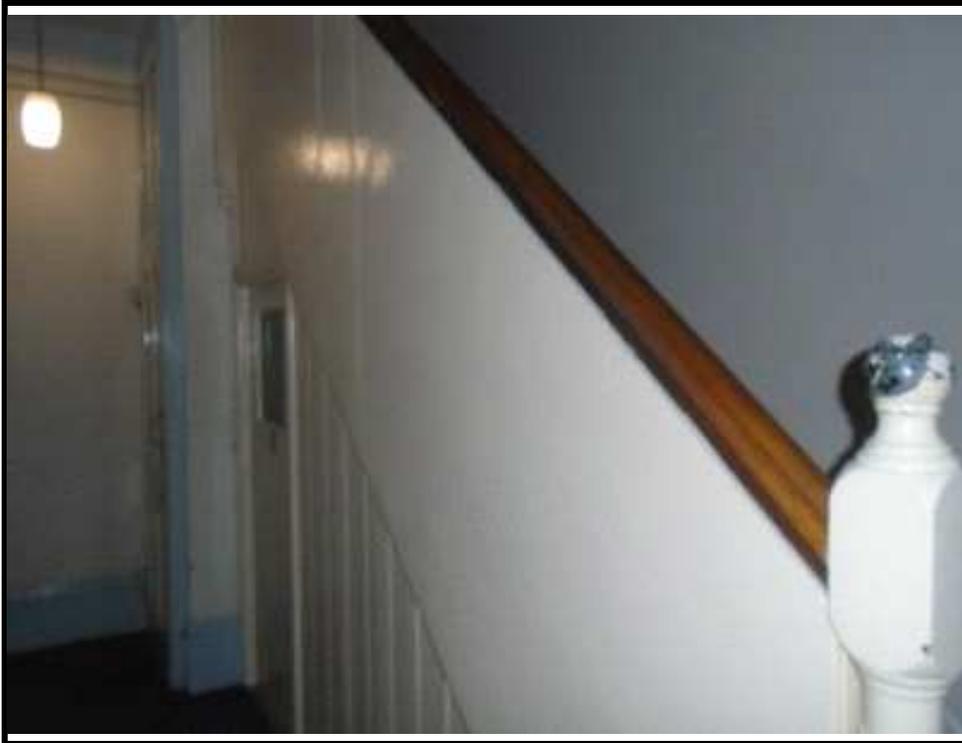
Property Sittingbourne Adult Education	Floor Ground Floor	Incident Number 16122015RCGA001
Room No. / Name G.005	Location Stairway Balustrade	Sample Reference A/001/16122015/RCG

Insulating Board Panels - 5m2

Location and Material: Ground Floor, G.005, Stairway Balustrade		VALUE	SCORE
POSITION	External	0	1
	Internal (Stairs, corridors, lift shafts, lofts, etc)	1	
	Internal (Occupied)	2	
	Internal forced ventilation over unsealed asbestos	4	
CONDITION	Good (Unblemished, not cut, drilled or machined)	0	2
	Fair (Indented or cracked but not broken away)	2	
	Poor (Small Part of edge or corner missing)	4	
	Bad (Significant damage/plant or material detached from wall)	6	
DAMAGE POTENTIAL	Difficult to touch, vandalize or hit with ball etc. No regular maintenance implication	0	4
	Some effort needed to reach, chair, ladder etc needed. No regular maintenance implication	1	
	Within normal reach of people using the building (e.g. distance to standard door height from nearest standing position)	4	
	Will be encountered in maintenance or by position has high potential to vandal damage	5	
	Likely to be disturbed or damaged in routine maintenance	10

FRIABILITY	Low (e.g. asbestos cement, vinyl tiles, vinyl gaskets)	1	2
	Medium (e.g. insulation board)	2	
	High (e.g. sprayed insulation, pipe insulation, woven materials)	5	
SURFACE TREATMENT	Behind rigid cover or structure	0	2
	Sealed with undamaged sealant or flexible cover	2	
	Untreated or with damaged seal or cover	4	
PRODUCT	Reinforced mastic products/Textured coatings/Thermoplastic flooring	0	4
	Asbestos Cement	1	
	Lagging/fibrous gasket/AIB	4	
	Sprayed Coatings	6	
Laboratory Results:	2. Amosite (brown asbestos)	Total:	15

No immediate action needed but check condition and assessment

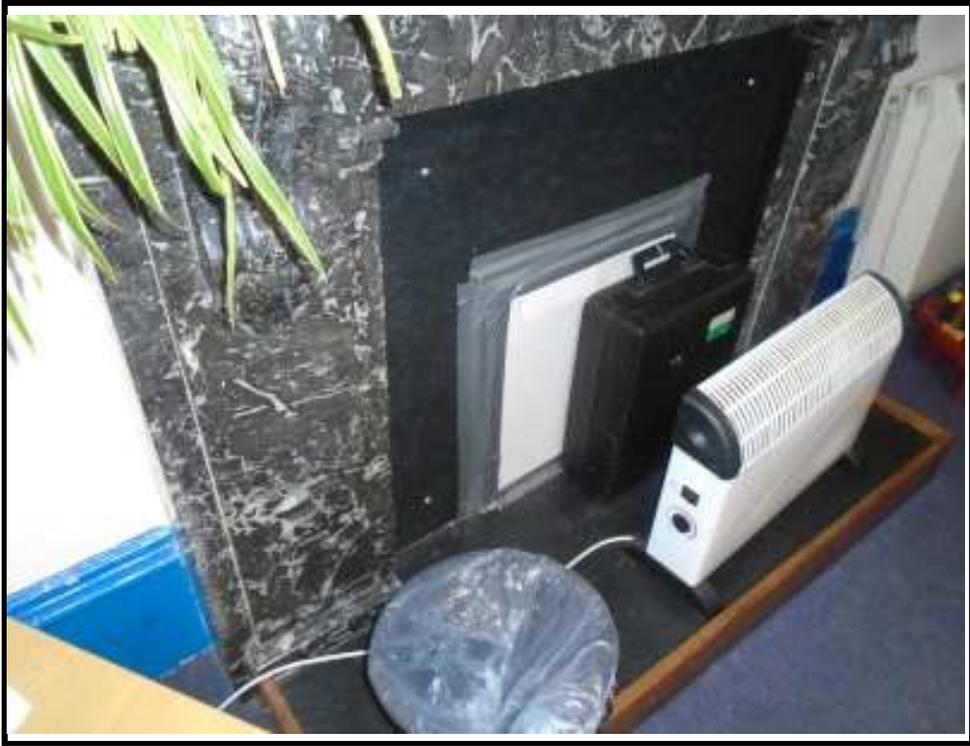
Property Sittingbourne Adult Education	Floor Ground Floor	Incident Number 16122015RCGA002
Room No. / Name G.003	Location Fireplace Surround	Sample Reference A/002/16122015/RCG

Composite Panels - 2m2

Location and Material: Ground Floor, G.003, Fireplace Surround		VALUE	SCORE
POSITION	External	0	2
	Internal (Stairs, corridors, lift shafts, lofts, etc)	1	
	Internal (Occupied)	2	
	Internal forced ventilation over unsealed asbestos	4	
CONDITION	Good (Unblemished, not cut, drilled or machined)	0	0
	Fair (Indented or cracked but not broken away)	2	
	Poor (Small Part of edge or corner missing)	4	
	Bad (Significant damage/plant or material detached from wall)	6	
DAMAGE POTENTIAL	Difficult to touch, vandalize or hit with ball etc. No regular maintenance implication	0	4
	Some effort needed to reach, chair, ladder etc needed. No regular maintenance implication	1	
	Within normal reach of people using the building (e.g. distance to standard door height from nearest standing position)	4	
	Will be encountered in maintenance or by position has high potential to vandal damage	5	
	Likely to be disturbed or damaged in routine maintenance	10

FRIABILITY	Low (e.g. asbestos cement, vinyl tiles, vinyl gaskets)	1	1
	Medium (e.g. insulation board)	2	
	High (e.g. sprayed insulation, pipe insulation, woven materials)	5	
SURFACE TREATMENT	Behind rigid cover or structure	0	4
	Sealed with undamaged sealant or flexible cover	2	
	Untreated or with damaged seal or cover	4	
PRODUCT	Reinforced mastic products/Textured coatings/Thermoplastic flooring	0	0
	Asbestos Cement	1	
	Lagging/fibrous gasket/AIB	4	
	Sprayed Coatings	6	
Laboratory Results:	1. Chrysotile (white asbestos)	Total:	11

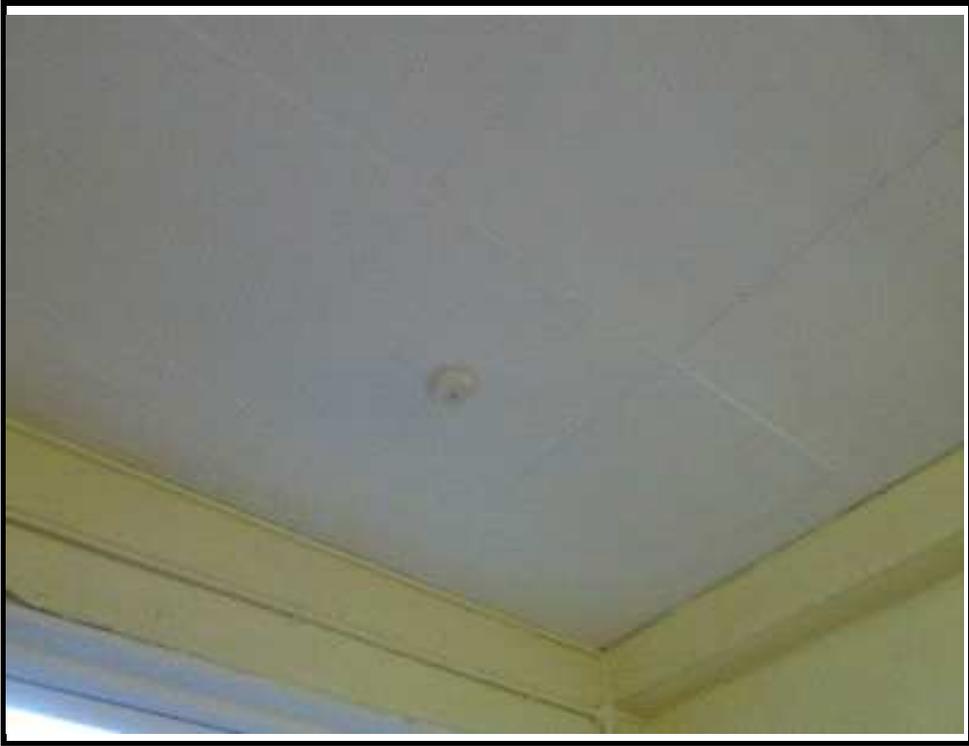
Property Sittingbourne Adult Education	Floor Ground Floor	Incident Number 16122015RCGA003
Room No. / Name G.024	Location Ceiling	Sample Reference A/003/16122015/RCG

Insulating Board Tiles - 25m2

Location and Material: Ground Floor, G.024, Ceiling		VALUE	SCORE
POSITION	External	0	2
	Internal (Stairs, corridors, lift shafts, lofts, etc)	1	
	Internal (Occupied)	2	
	Internal forced ventilation over unsealed asbestos	4	
CONDITION	Good (Unblemished, not cut, drilled or machined)	0	2
	Fair (Indented or cracked but not broken away)	2	
	Poor (Small Part of edge or corner missing)	4	
	Bad (Significant damage/plant or material detached from wall)	6	
DAMAGE POTENTIAL	Difficult to touch, vandalize or hit with ball etc. No regular maintenance implication	0	1
	Some effort needed to reach, chair, ladder etc needed. No regular maintenance implication	1	
	Within normal reach of people using the building (e.g. distance to standard door height from nearest standing position)	4	
	Will be encountered in maintenance or by position has high potential to vandal damage	5	
	Likely to be disturbed or damaged in routine maintenance	10

FRIABILITY	Low (e.g. asbestos cement, vinyl tiles, vinyl gaskets)	1	2
	Medium (e.g. insulation board)	2	
	High (e.g. sprayed insulation, pipe insulation, woven materials)	5	
SURFACE TREATMENT	Behind rigid cover or structure	0	2
	Sealed with undamaged sealant or flexible cover	2	
	Untreated or with damaged seal or cover	4	
PRODUCT	Reinforced mastic products/Textured coatings/Thermoplastic flooring	0	4
	Asbestos Cement	1	
	Lagging/fibrous gasket/AIB	4	
	Sprayed Coatings	6

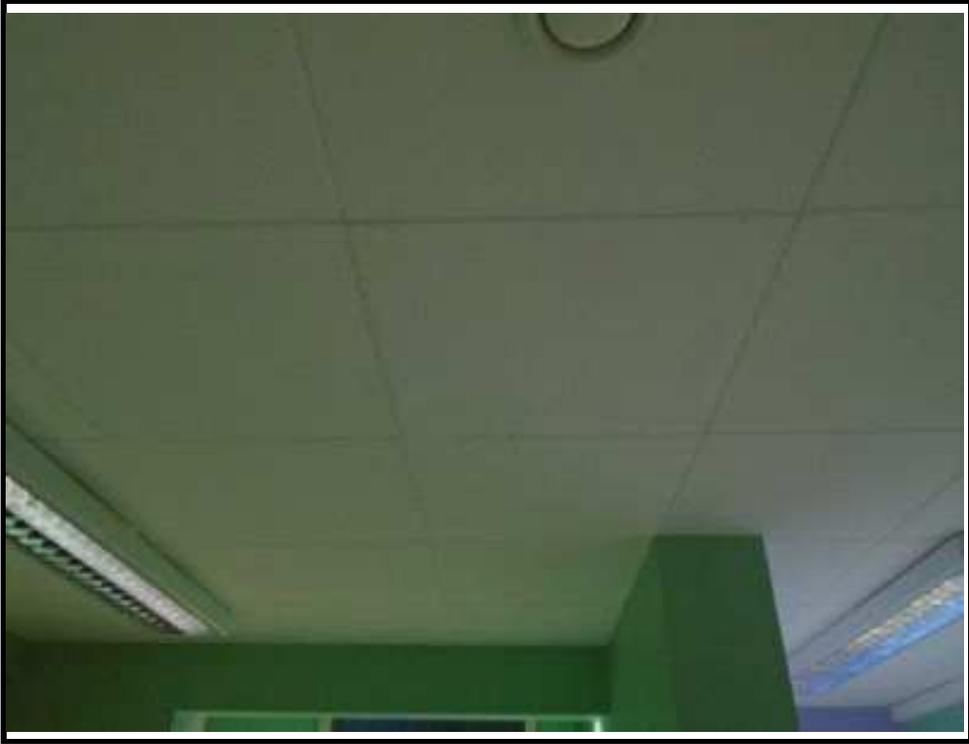
Property Sittingbourne Adult Education	Floor Ground Floor	Incident Number 16122015RCGA005
Room No. / Name G.016	Location Ceiling	Sample Reference A/004/16122015/RCG

Insulating Board Tiles - 20m2

Location and Material: Ground Floor, G.016, Ceiling		VALUE	SCORE
POSITION	External	0	2
	Internal (Stairs, corridors, lift shafts, lofts, etc)	1	
	Internal (Occupied)	2	
	Internal forced ventilation over unsealed asbestos	4	
CONDITION	Good (Unblemished, not cut, drilled or machined)	0	2
	Fair (Indented or cracked but not broken away)	2	
	Poor (Small Part of edge or corner missing)	4	
	Bad (Significant damage/panel or material detached from wall)	6	
DAMAGE POTENTIAL	Difficult to touch, vandalize or hit with ball etc. No regular maintenance implication	0	1
	Some effort needed to reach, chair, ladder etc needed. No regular maintenance implication	1	
	Within normal reach of people using the building (e.g. distance to standard door height from nearest standing position)	4	
	Will be encountered in maintenance or by position has high potential to vandal damage	5	
	Likely to be disturbed or damaged in routine maintenance	10

FRIABILITY	Low (e.g. asbestos cement, vinyl tiles, vinyl gaskets)	1	2
	Medium (e.g. insulation board)	2	
	High (e.g. sprayed insulation, pipe insulation, woven materials)	5	
SURFACE TREATMENT	Behind rigid cover or structure	0	2
	Sealed with undamaged sealant or flexible cover	2	
	Untreated or with damaged seal or cover	4	
PRODUCT	Reinforced mastic products/Textured coatings/Thermoplastic flooring	0	4
	Asbestos Cement	1	
	Lagging/fibrous gasket/AIB	4	
	Sprayed Coatings	6

No immediate action needed but check condition and assessment

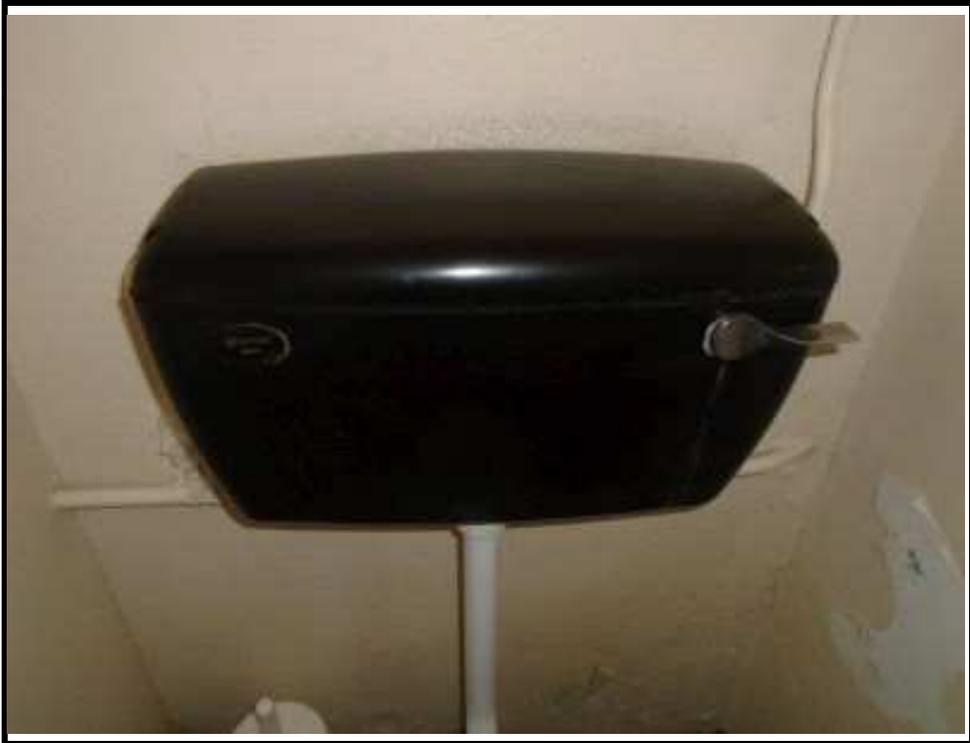
Property Sittingbourne Adult Education	Floor Ground Floor	Incident Number 16122015RCGA006
Room No. / Name G.040	Location Toilet	Sample Reference A/005/16122015/RCG

Composite Cisterns - 2Qty

Location and Material: Ground Floor, G.040, Toilet		VALUE	SCORE
POSITION	External	0	1
	Internal (Stairs, corridors, lift shafts, lofts, etc)	1	
	Internal (Occupied)	2	
	Internal forced ventilation over unsealed asbestos	4	
CONDITION	Good (Unblemished, not cut, drilled or machined)	0	0
	Fair (Indented or cracked but not broken away)	2	
	Poor (Small Part of edge or corner missing)	4	
	Bad (Significant damage/plant or material detached from wall)	6	
DAMAGE POTENTIAL	Difficult to touch, vandalize or hit with ball etc. No regular maintenance implication	0	4
	Some effort needed to reach, chair, ladder etc needed. No regular maintenance implication	1	
	Within normal reach of people using the building (e.g. distance to standard door height from nearest standing position)	4	
	Will be encountered in maintenance or by position has high potential to vandal damage	5	
	Likely to be disturbed or damaged in routine maintenance	10

FRIABILITY	Low (e.g. asbestos cement, vinyl tiles, vinyl gaskets)	1	1
	Medium (e.g. insulation board)	2	
	High (e.g. sprayed insulation, pipe insulation, woven materials)	5	
SURFACE TREATMENT	Behind rigid cover or structure	0	4
	Sealed with undamaged sealant or flexible cover	2	
	Untreated or with damaged seal or cover	4	
PRODUCT	Reinforced mastic products/Textured coatings/Thermoplastic flooring	0	0
	Asbestos Cement	1	
	Lagging/fibrous gasket/AIB	4	
	Sprayed Coatings	6	
Laboratory Results:	2. Amosite (brown asbestos)	Total:	10

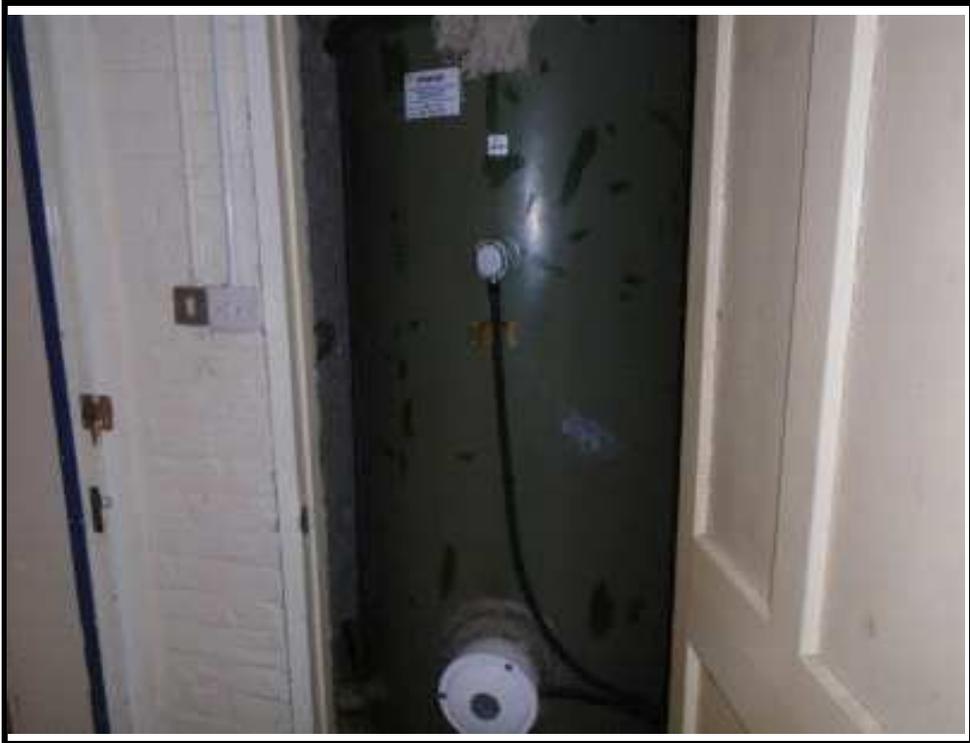
Property Sittingbourne Adult Education	Floor Ground Floor	Incident Number 16122015RCGA007
Room No. / Name G.039	Location Boiler (Manufactured 1966)	Sample Reference Presumed

Rope Seals - 1Qty		
Asbestos Re-inspection		
<u>UPDATE 1</u>	<u>UPDATE 2</u>	<u>UPDATE 3</u>
Company STAMP here if condition UPDATED	Company STAMP here if condition UPDATED	Company STAMP here if condition UPDATED
Date: Name: Signature:	Date: Name: Signature:	Date: Name: Signature:

Location and Material: Ground Floor, G.039, Boiler (Manufactured 1966)		VALUE	SCORE
POSITION	External	0	1
	Internal (Stairs, corridors, lift shafts, lofts, etc)	1	
	Internal (Occupied)	2	
	Internal forced ventilation over unsealed asbestos	4	
CONDITION	Good (Unblemished, not cut, drilled or machined)	0	0
	Fair (Indented or cracked but not broken away)	2	
	Poor (Small Part of edge or corner missing)	4	
	Bad (Significant damage/plant or material detached from wall)	6	
DAMAGE POTENTIAL	Difficult to touch, vandalize or hit with ball etc. No regular maintenance implication	0	0
	Some effort needed to reach, chair, ladder etc needed. No regular maintenance implication	1	
	Within normal reach of people using the building (e.g. distance to standard door height from nearest standing position)	4	
	Will be encountered in maintenance or by position has high potential to vandal damage	5	
	Likely to be disturbed or damaged in routine maintenance	10

FRIABILITY	Low (e.g. asbestos cement, vinyl tiles, vinyl gaskets)	1	5
	Medium (e.g. insulation board)	2	
	High (e.g. sprayed insulation, pipe insulation, woven materials)	5	
SURFACE TREATMENT	Behind rigid cover or structure	0	0
	Sealed with undamaged sealant or flexible cover	2	
	Untreated or with damaged seal or cover	4	
PRODUCT	Reinforced mastic products/Textured coatings/Thermoplastic flooring	0	4
	Asbestos Cement	1	
	Lagging/fibrous gasket/AIB	4	
	Sprayed Coatings	6

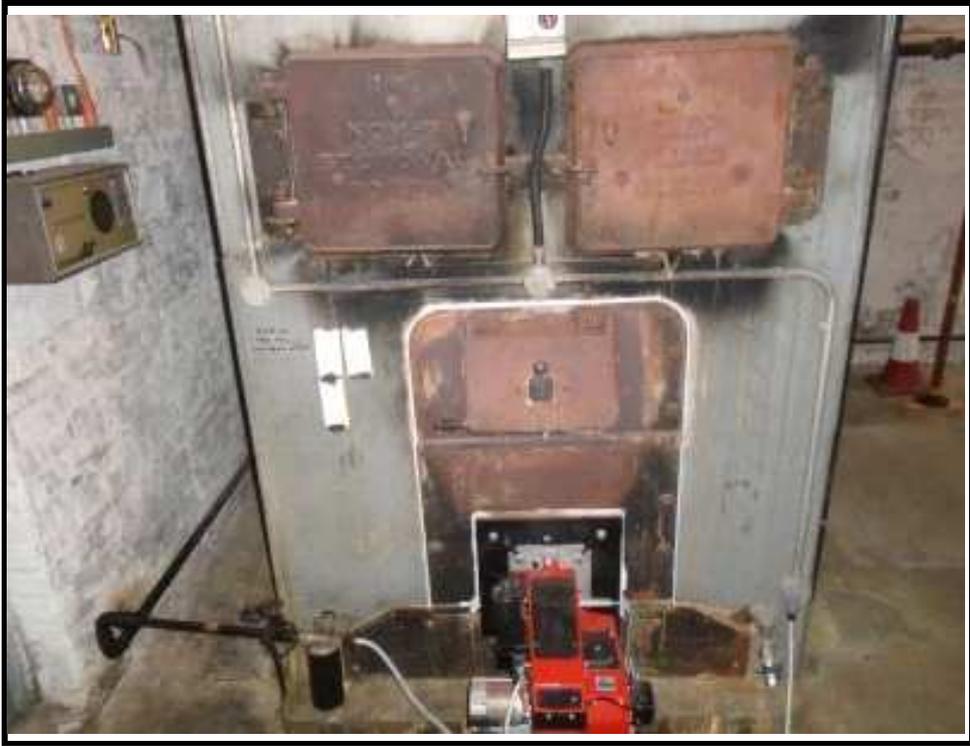
Property Sittingbourne Adult Education	Floor Basement	Incident Number 16122015RCGA008
Room No. / Name B.004	Location Boiler	Sample Reference Presumed

Rope Seals - 1Qty

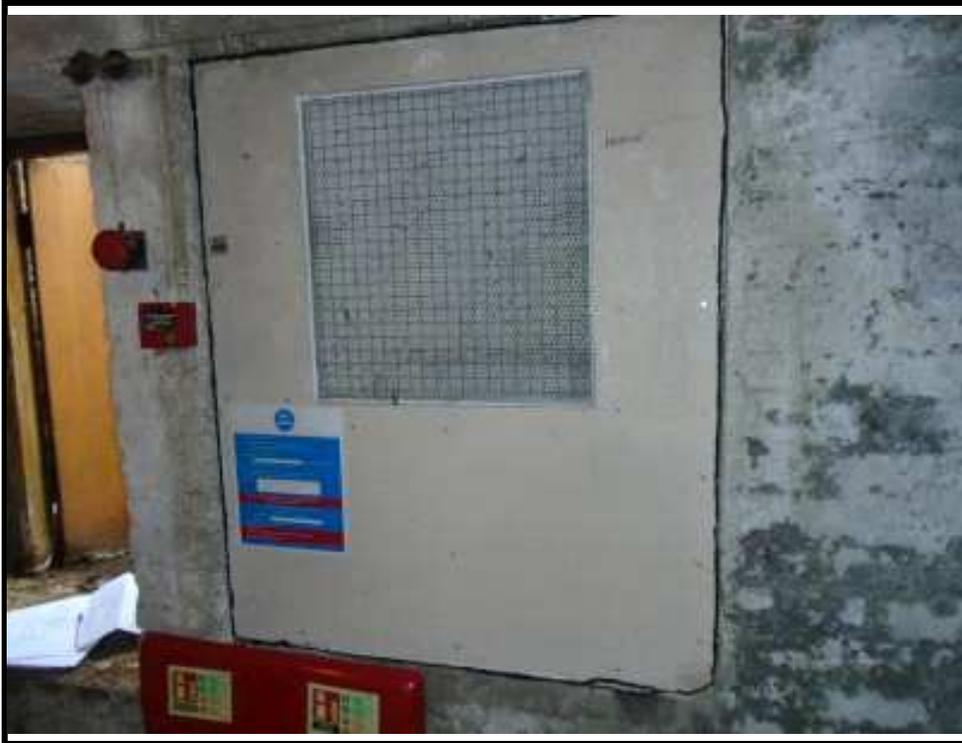
Property Sittingbourne Adult Education	Floor Basement	Incident Number 16122015RCGA009
Room No. / Name B.004	Location Wall Vent Surround	Sample Reference A/006/16122015/RCG

Insulating Board - 1m2

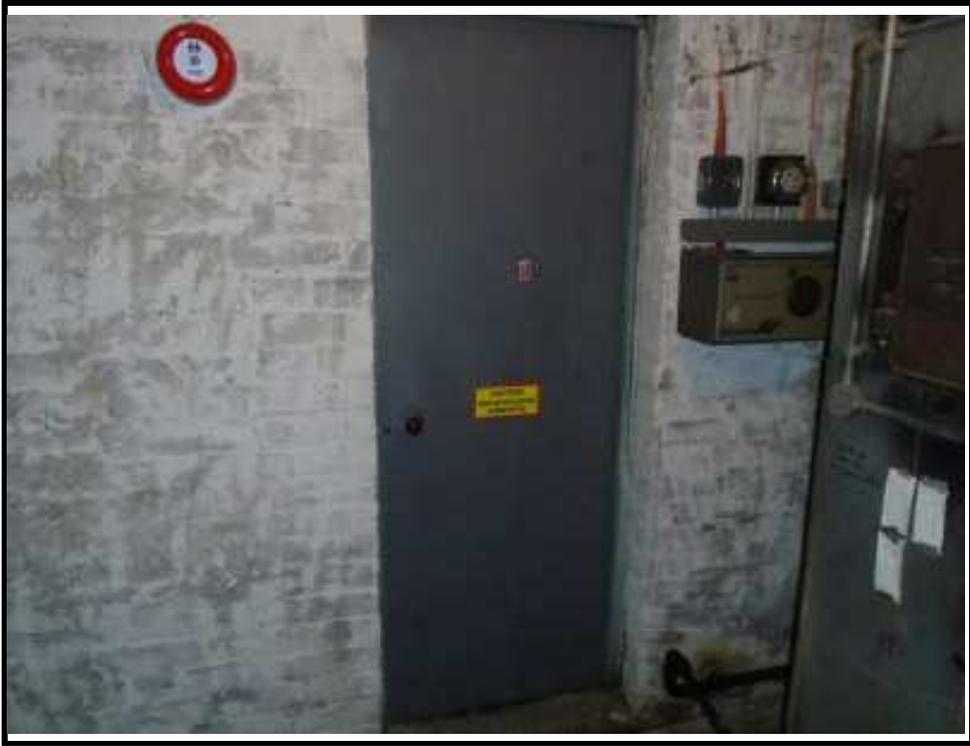
Property Sittingbourne Adult Education	Floor Basement	Incident Number 16122015RCGA010
Room No. / Name B.004	Location Panel to Door	Sample Reference A/007/16122015/RCG

Insulating Board - 2m2

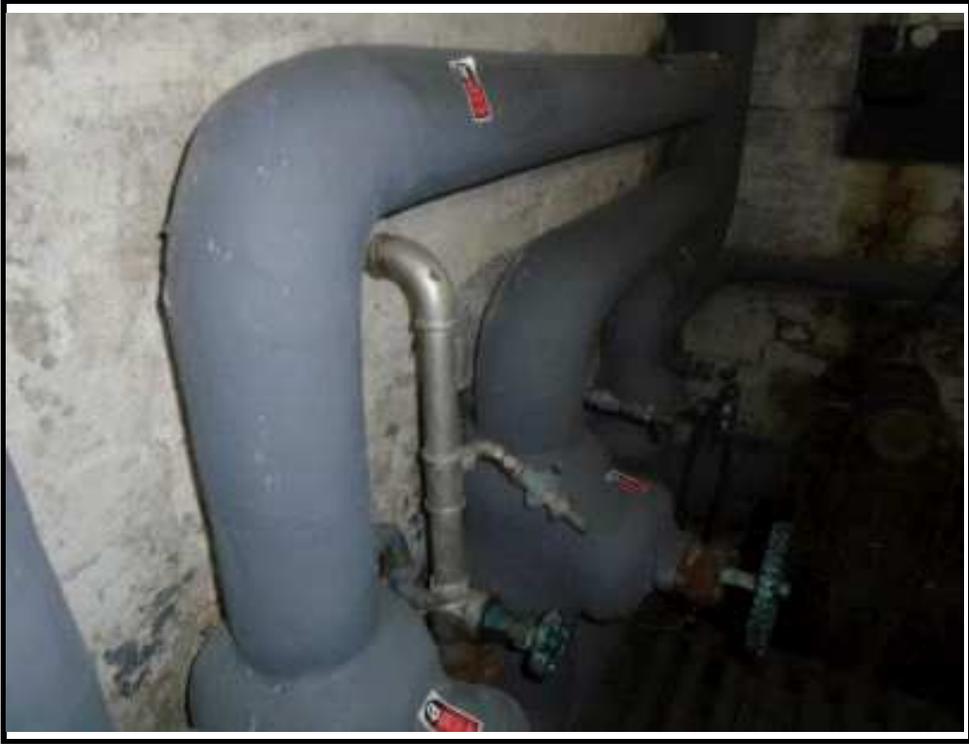
Property Sittingbourne Adult Education	Floor Basement	Incident Number 16122015RCGA011
Room No. / Name B.004, B.005 & B.006	Location Pipework	Sample Reference A/008/16122015/RCG

Thermal Insulation - 25L/m

No immediate action needed but check condition and assessment

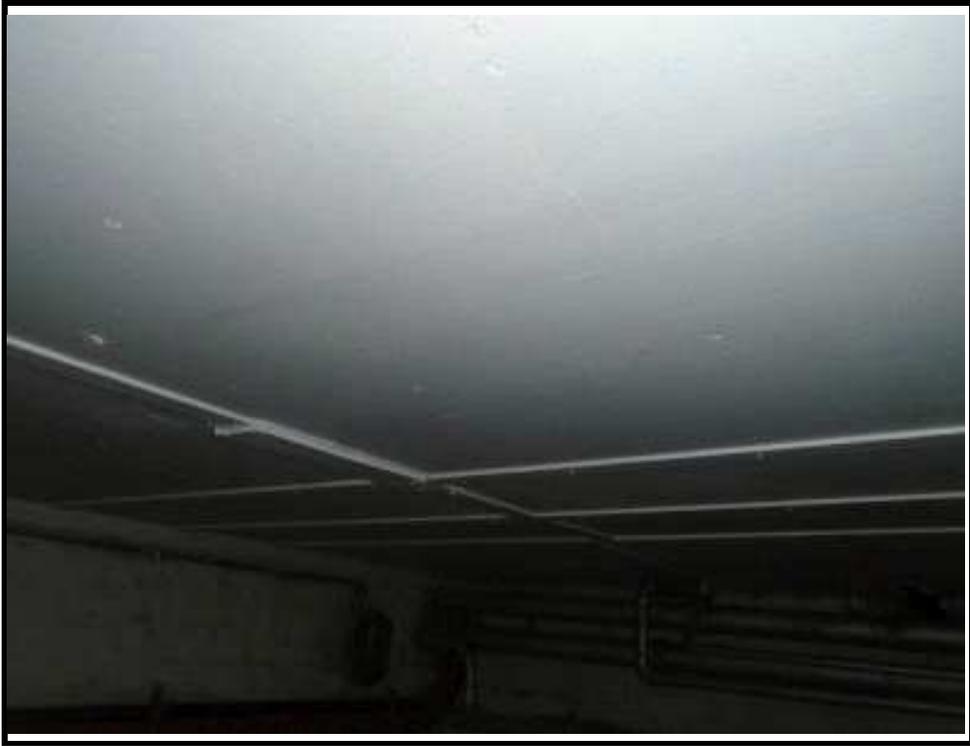
Property Sittingbourne Adult Education	Floor Basement	Incident Number 16122015RCGA012
Room No. / Name B.006	Location Ceiling Panels	Sample Reference A/009/16122015/RCG

Insulating Board - 10m2

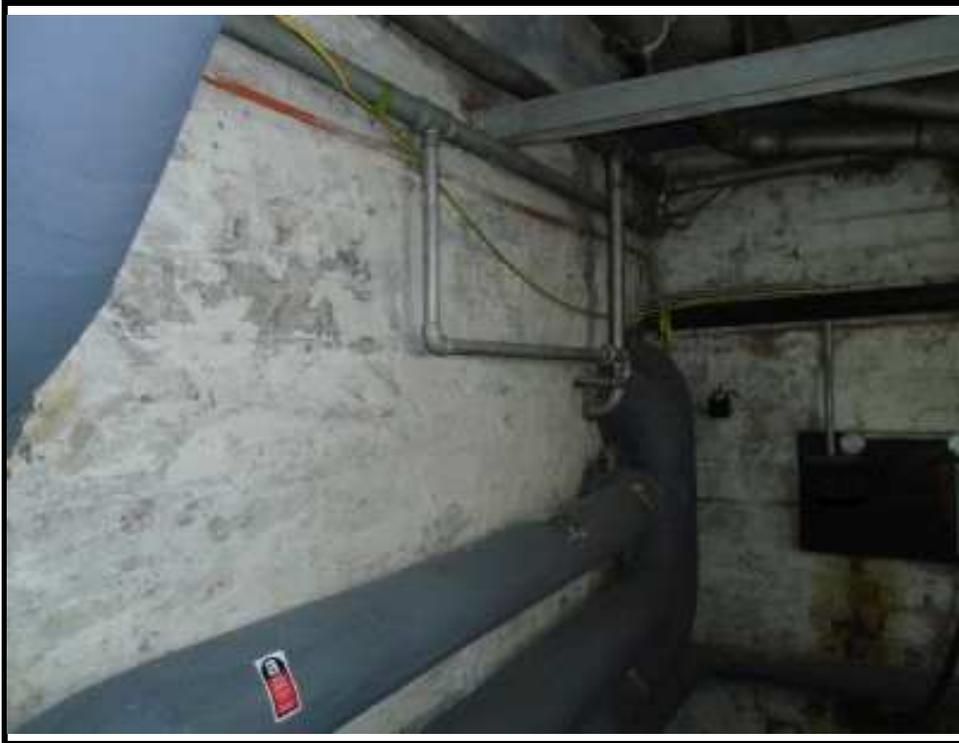
Property Sittingbourne Adult Education	Floor Basement	Incident Number 16122015RCGA013
Room No. / Name B.006	Location Painted Walls	Sample Reference A/010/16122015/RCG

Thermal Insulation Residue - 20m2

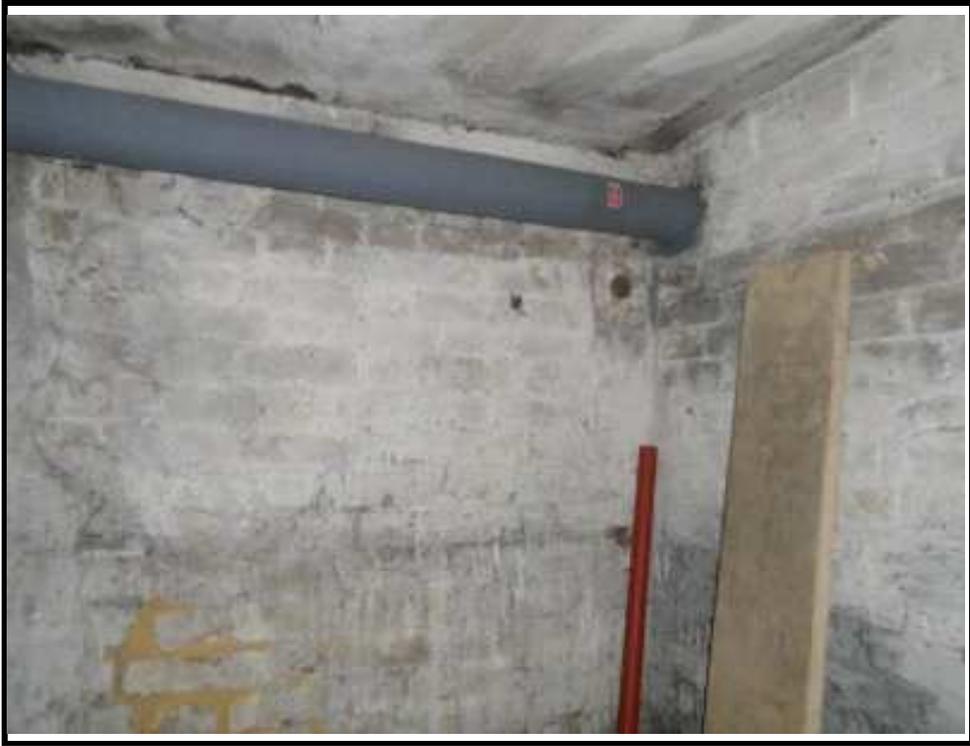
Property Sittingbourne Adult Education	Floor Basement	Incident Number 16122015RCGA014
Room No. / Name B.005	Location Painted Walls	Sample Reference A/011/16122015/RCG

Thermal Insulation Residue - 22m2

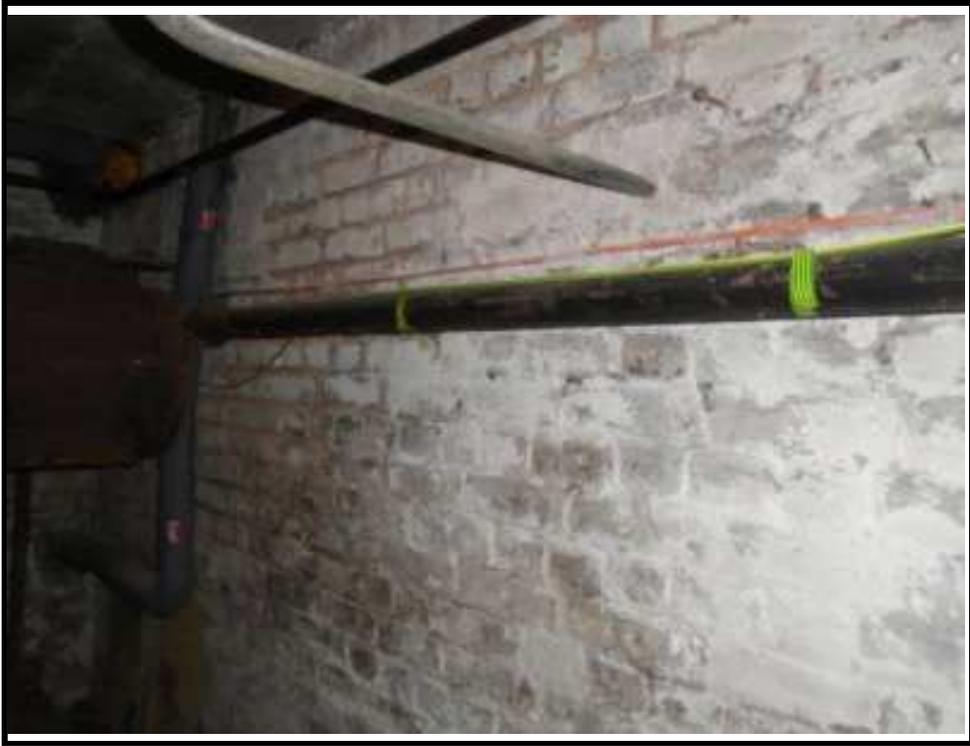
Property Sittingbourne Adult Education	Floor Basement	Incident Number 16122015RCGA015
Room No. / Name B.004	Location Painted Walls	Sample Reference A/012/16122015/RCG

Thermal Insulation Residue - 25m2

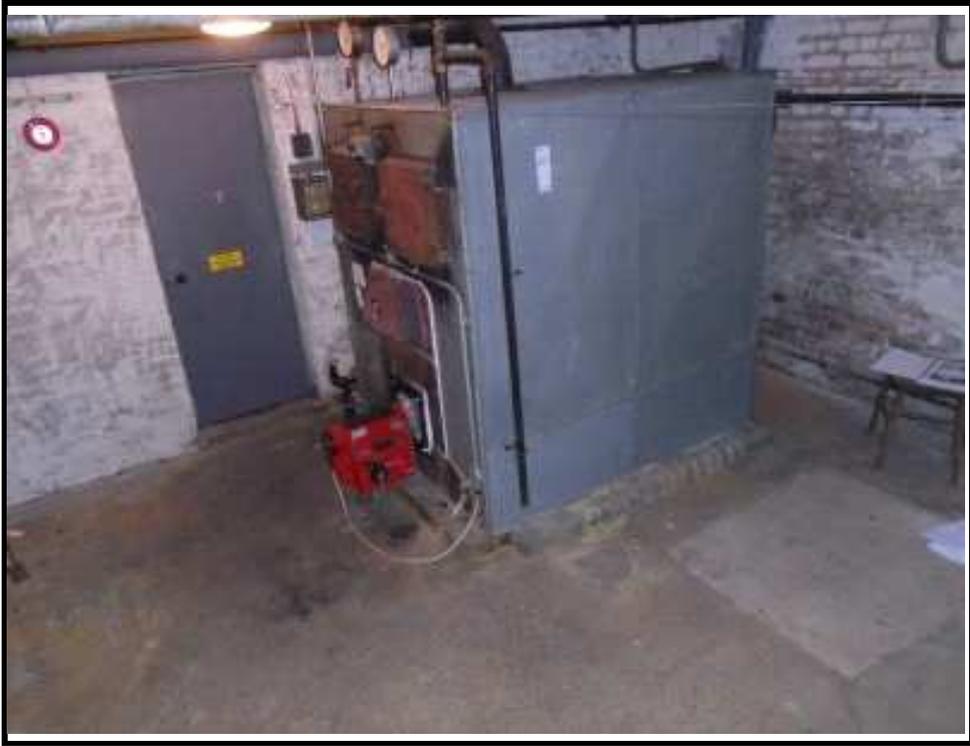
Property Sittingbourne Adult Education	Floor Basement	Incident Number 16122015RCGA016
Room No. / Name B.004, B.005 & B.006	Location All Walls & Surfaces	Sample Reference Ref: A/010/16122015/RCG

Thermal Insulation Residue - Extensive

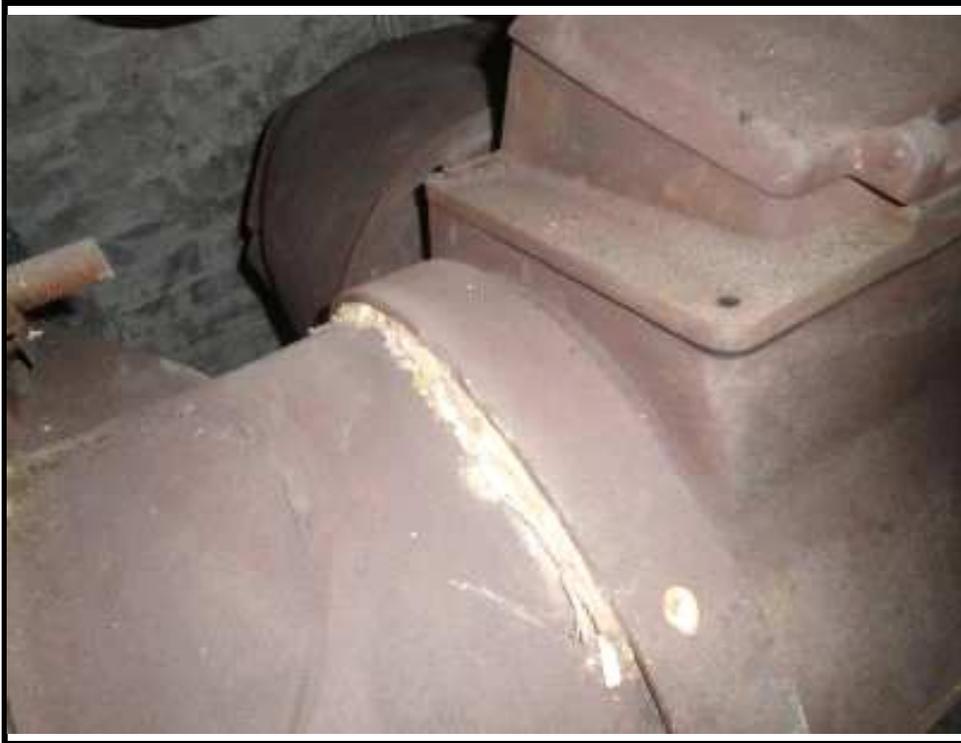
Property Sittingbourne Adult Education	Floor Basement	Incident Number 16122015RCGA017
Room No. / Name B.004	Location Boiler Flue	Sample Reference A/013/16122015/RCG

Rope Seal - 1L/m

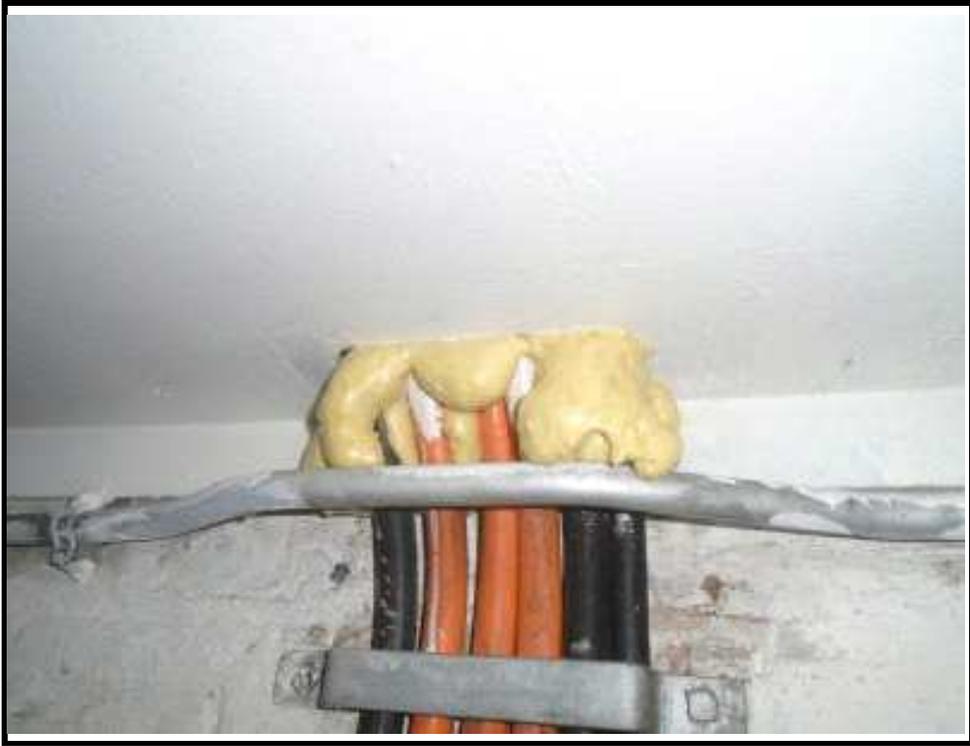
Property Sittingbourne Adult Education	Floor Basement	Incident Number 16122015RCGA018
Room No. / Name B.004, B.005 & B.006	Location Electrical/Mechanical Service Holes	Sample Reference Presumed

Rope Packing - Extensive

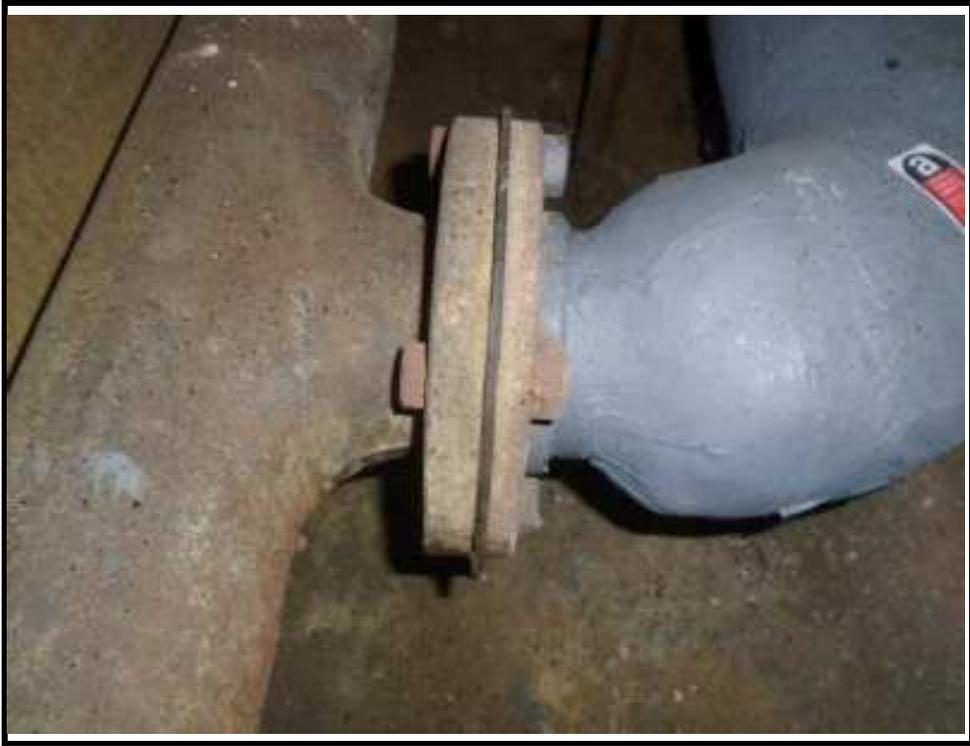
Property Sittingbourne Adult Education	Floor All Floors	Incident Number 16122015RCGA019
Room No. / Name All Areas	Location Pipework	Sample Reference Presumed

Composite Flange Gaskets - Extensive

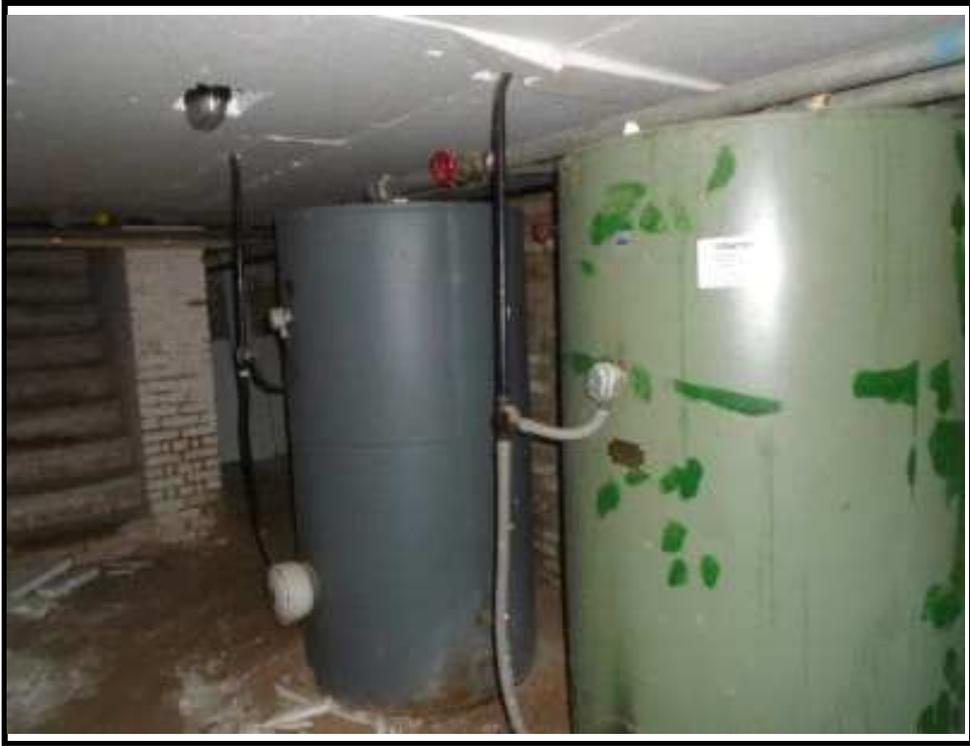
Property Sittingbourne Adult Education	Floor Basement	Incident Number 16122015RCGA020
Room No. / Name B.008	Location Boilers x2	Sample Reference Presumed

Rope Seals - 2Qty

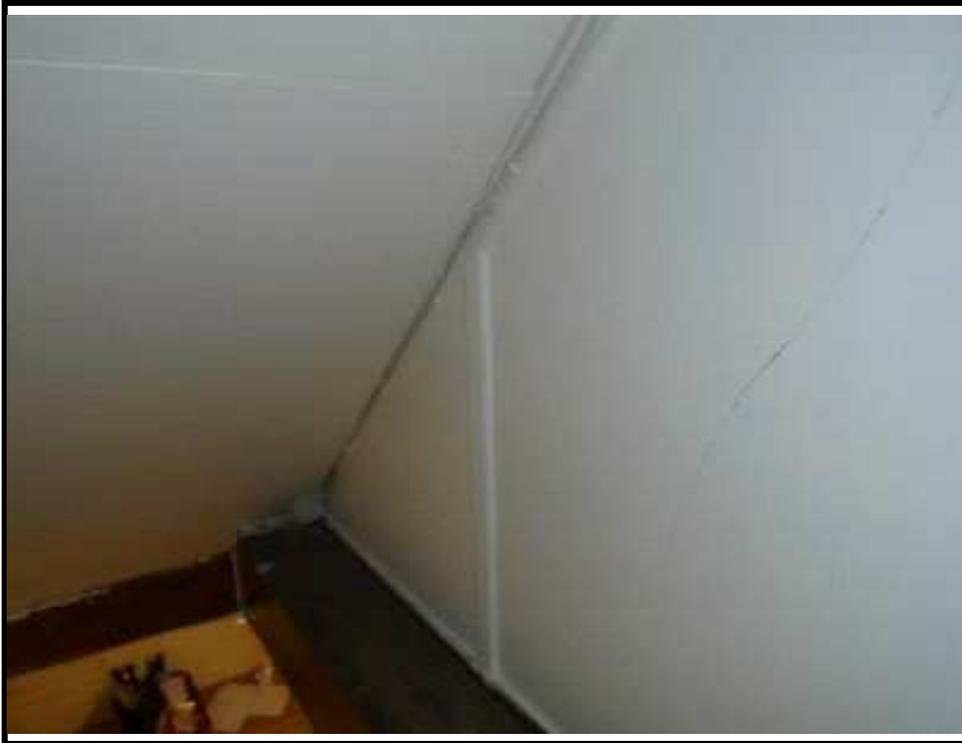
Property Sittingbourne Adult Education	Floor Basement	Incident Number 16122015RCGA021
Room No. / Name B.001	Location Ceiling & Wall Panels To Stairs	Sample Reference A/014/16122015/RCG

Insulating Board - 8m2

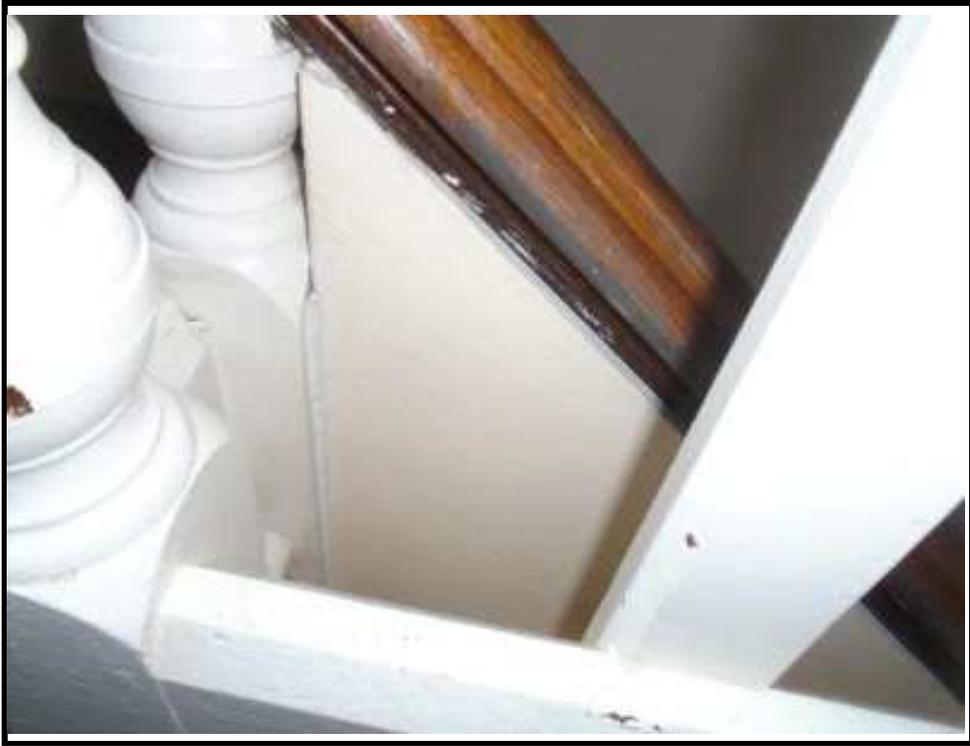
Property Sittingbourne Adult Education	Floor First Floor	Incident Number 16122015RCGA022
Room No. / Name 1.010	Location Stairway Balustrade	Sample Reference Ref: A/001/16122015/RCG

Insulating Board Panels - 1m2

16122015RCGA022
1.010
Stairway Balustrade
Insulating Board Panels (1m2)
Amosite – Ongoing safe management of item in situ.

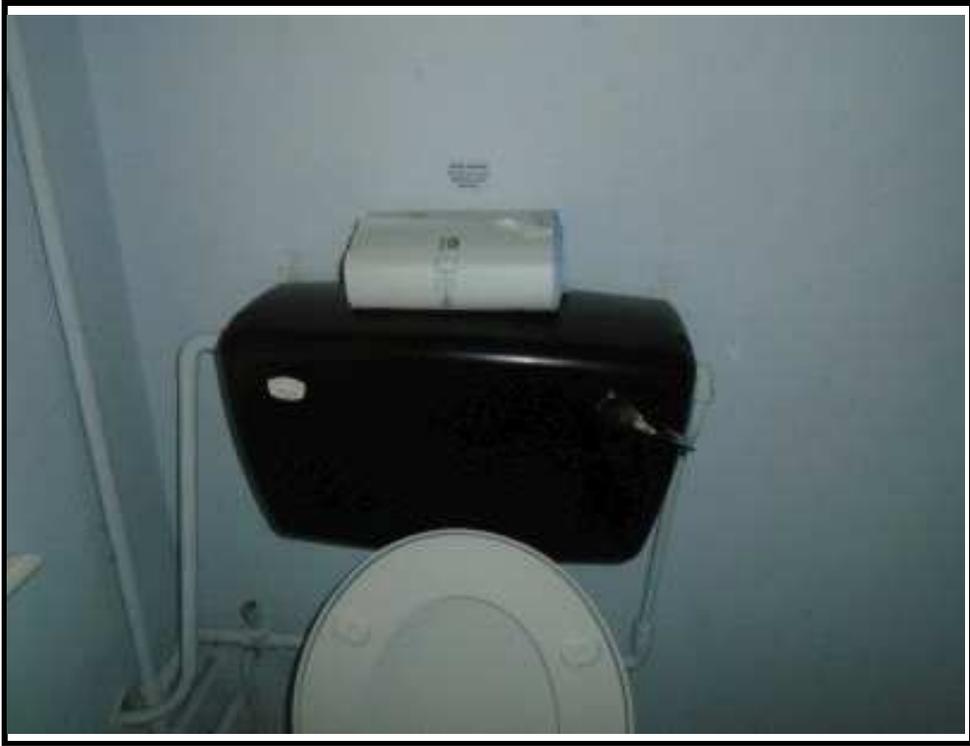
Property Sittingbourne Adult Education	Floor First Floor	Incident Number 16122015RCGA023
Room No. / Name 1.011	Location Toilet	Sample Reference Ref: A/005/16122015/RCG

Composite Cistern - 1Qty

16122015RCGA023
1.011
Toilet
Composite Cistern (1 Qty)
Amosite – Ongoing safe management of item in situ.

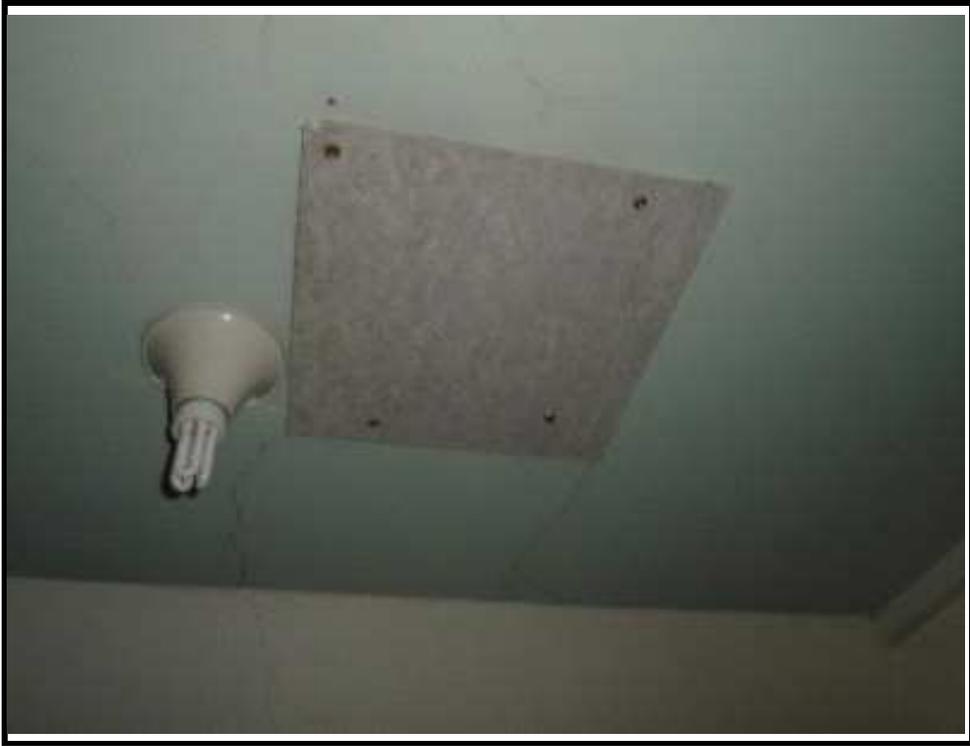
Property Sittingbourne Adult Education	Floor Second Floor	Incident Number 16122015RCGA024
Room No. / Name 2.005	Location Ceiling	Sample Reference A/015/16122015/RCG

Insulating Board Panel - 0.25m2

16122015RCGA024
 2.005
 Ceiling
 Insulating Board Panel (0.25m²)
 No asbestos detected. No action required.

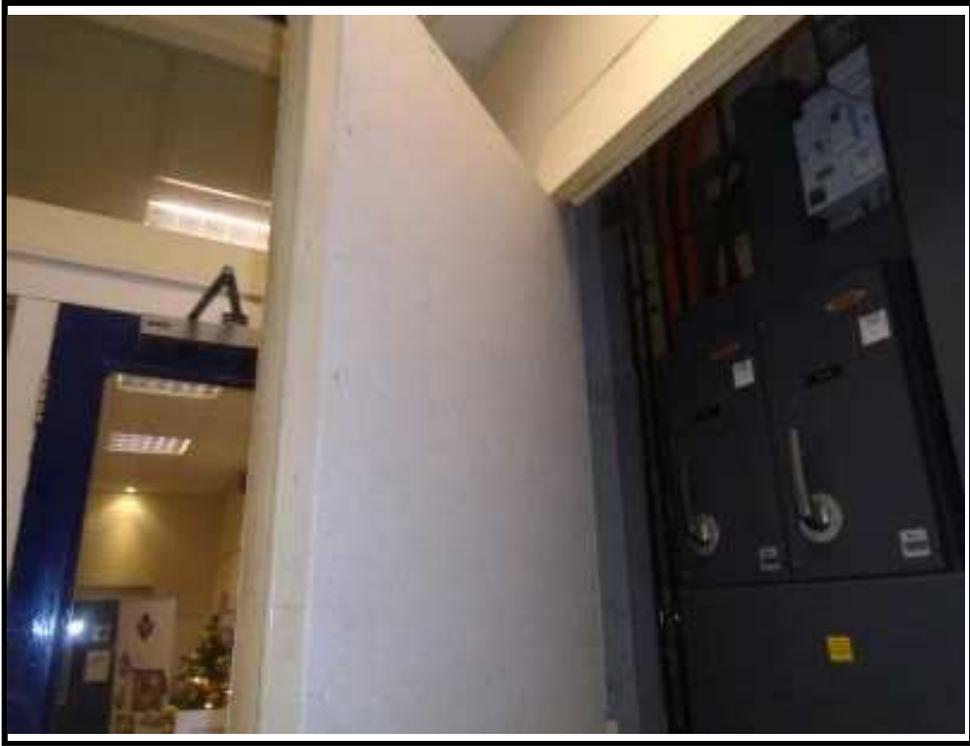
Property Sittingbourne Adult Education	Floor Ground Floor	Incident Number 16122015RCGA025
Room No. / Name G.044	Location Electrical Cupboard	Sample Reference A/016/16122015/RCG

Insulating Board Panels To Doors - 6m2

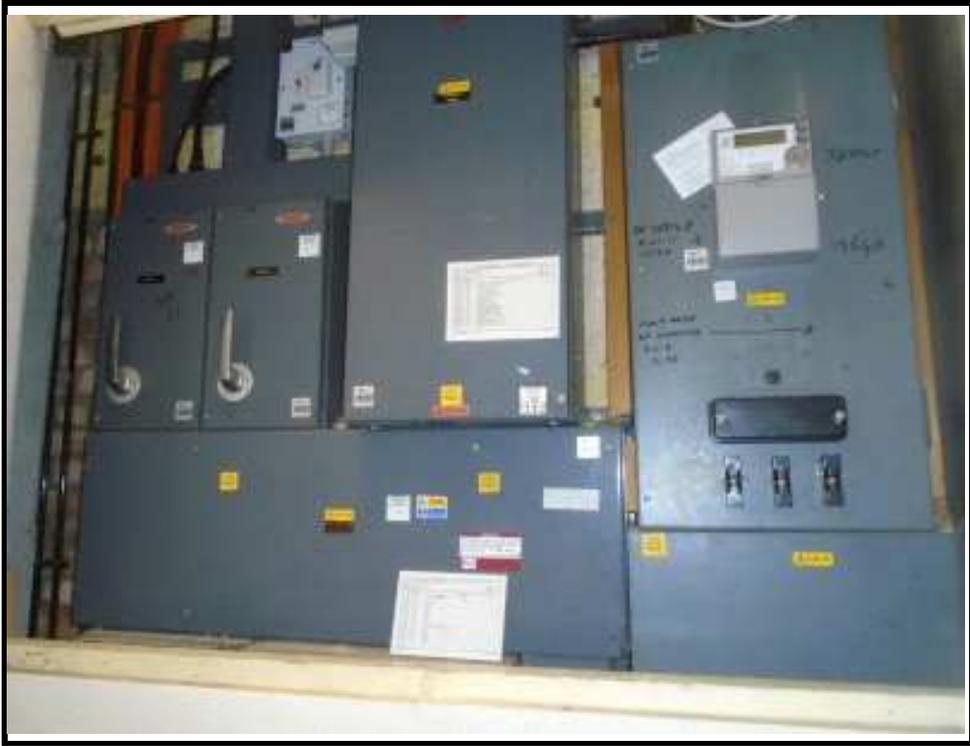
Property Sittingbourne Adult Education	Floor All Floors	Incident Number 16122015RCGA026
Room No. / Name All Areas	Location Electrical Switch Gear	Sample Reference Presumed

Textile Flash Guards - Extensive

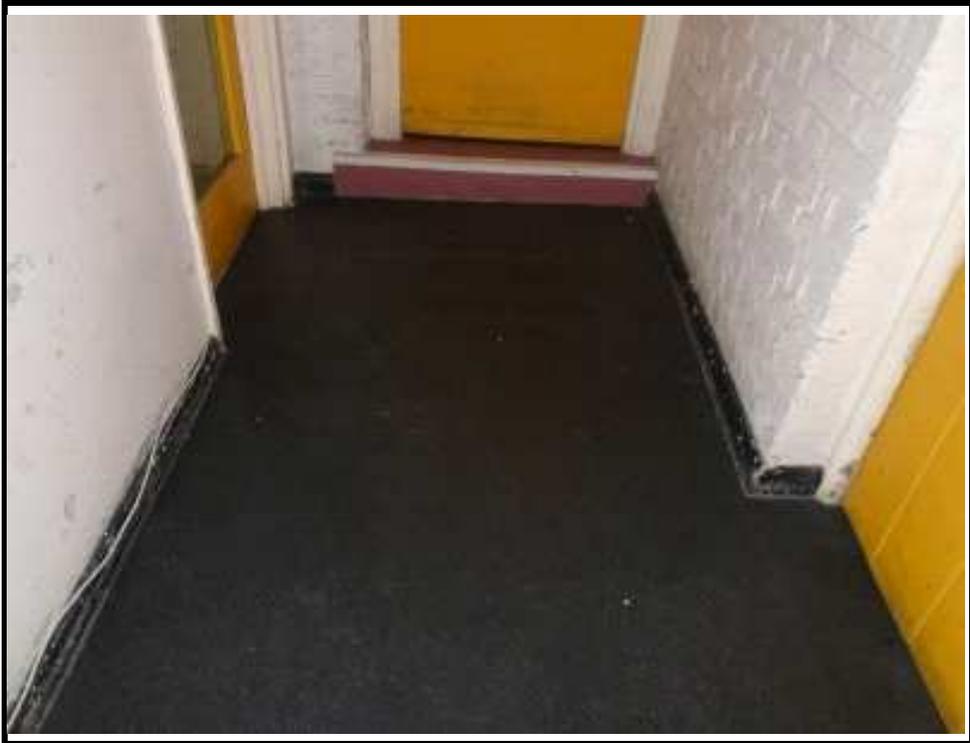
Property Sittingbourne Adult Education	Floor Ground Floor	Incident Number 16122015RCGA029
Room No. / Name Throughout	Location Below Modern Vinyl Flooring	Sample Reference Presumed

Composite Floor Tiles - Extensive
