Asbestos Management Survey Report:

Sittingbourne Adult Education Centre
College Road
Sittingbourne
Kent
ME10 1LF
United Kingdom

Date of survey:	Wednesday 16 th December 2015
Surveyors Name:	Robert Grover
Analyst / Quality Manager Name:	Phil Ogden
Signature:

Client:	Kent County Council Sessions House County Hall Maidstone Kent ME14 1XQ
Revision No.	001

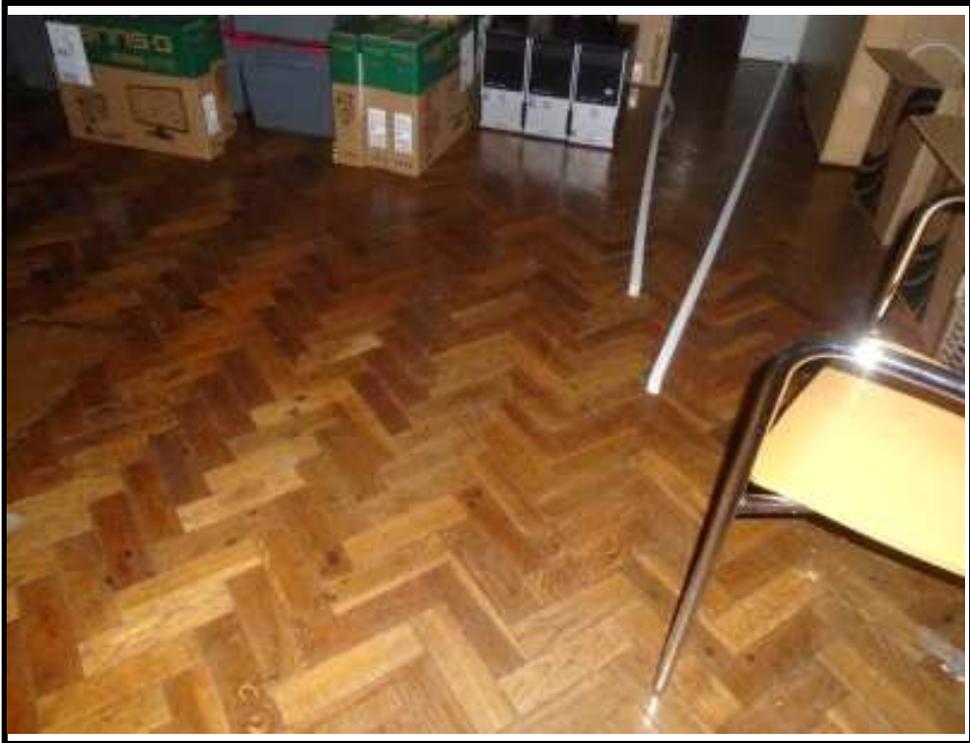
Property Sittingbourne Adult Education	Floor Ground Floor	Incident Number 16122015RCGA030
Room No. / Name Block B - G.007	Location Parquet Flooring	Sample Reference Presumed

Bitumen Adhesive - 36m2

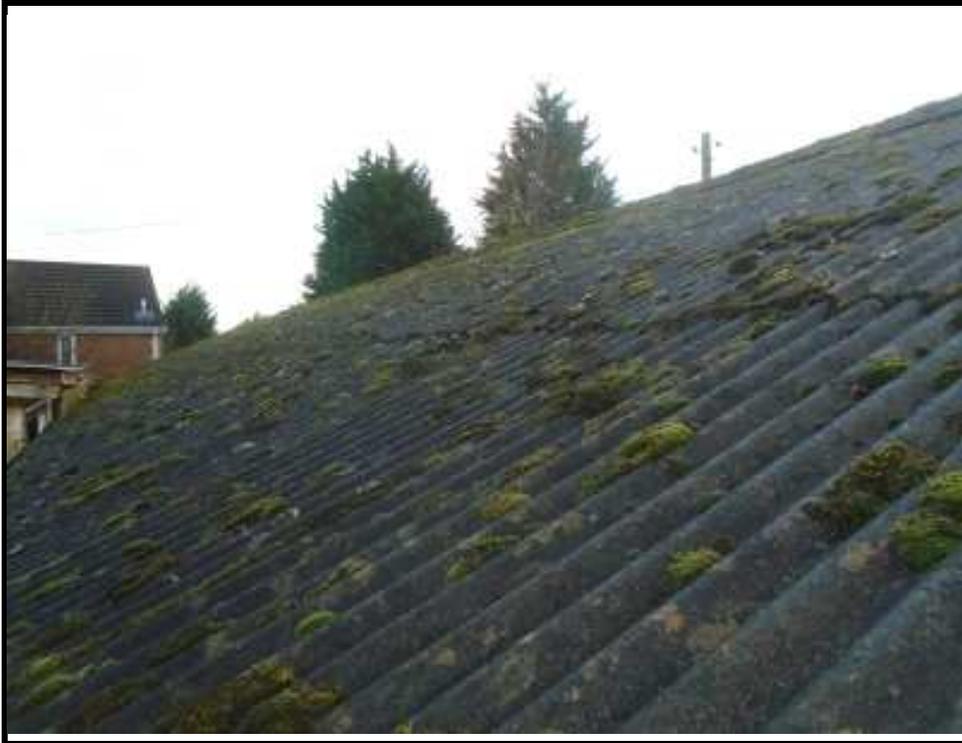
Property Sittingbourne Adult Education	Floor Roof	Incident Number 16122015RCGA031
Room No. / Name Block B	Location Roof Area	Sample Reference A/017/16122015/RCG

Cement Roofing Sheets - 160m2

16122015RCGA031
 Block B
 Roof Area
 Cement Roofing Sheets (160m2)
 Chrysotile – Ongoing safe management of item in situ.

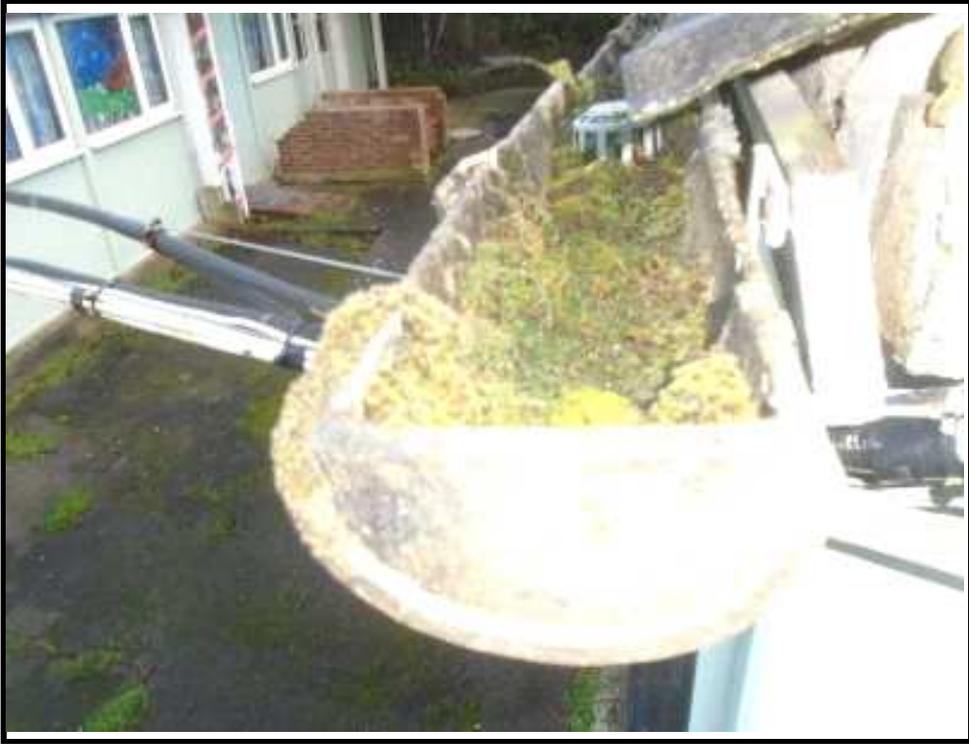
Property Sittingbourne Adult Education	Floor Roof	Incident Number 16122015RCGA032
Room No. / Name Block B	Location Roof Area	Sample Reference A/018/16122015/RCG

Cement Rainwater Goods - 45L/m

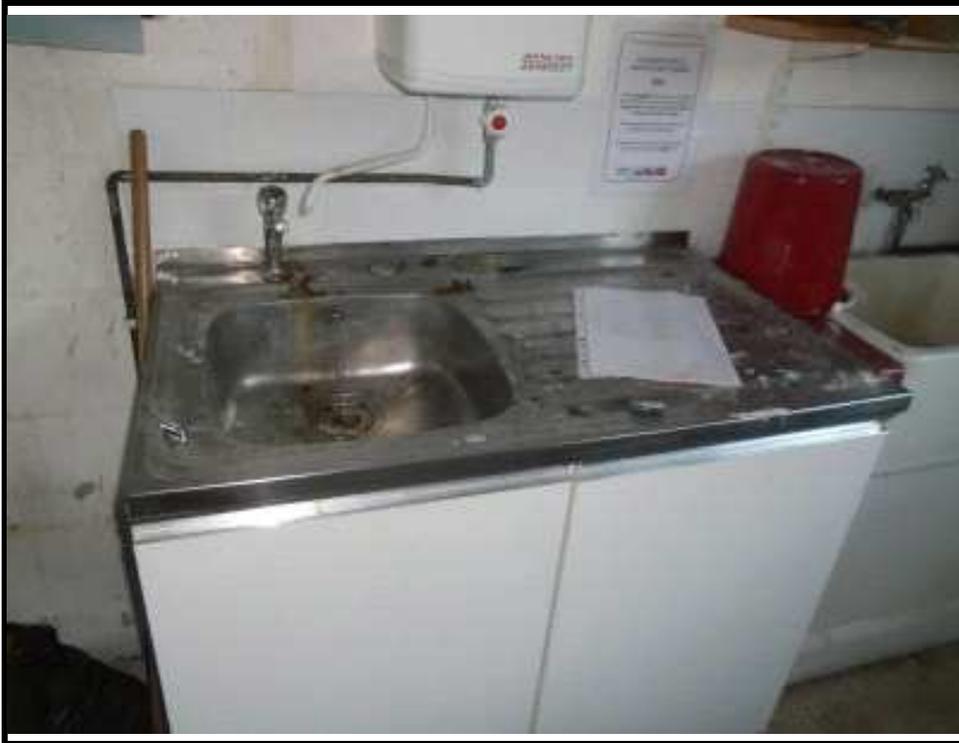
Property Sittingbourne Adult Education	Floor Ground Floor	Incident Number 16122015RCGA033
Room No. / Name Block C - G.001 & G.002	Location Sink Unit	Sample Reference A/019/16122015/RCG

Bitumen Acoustic Pad - 2Qty

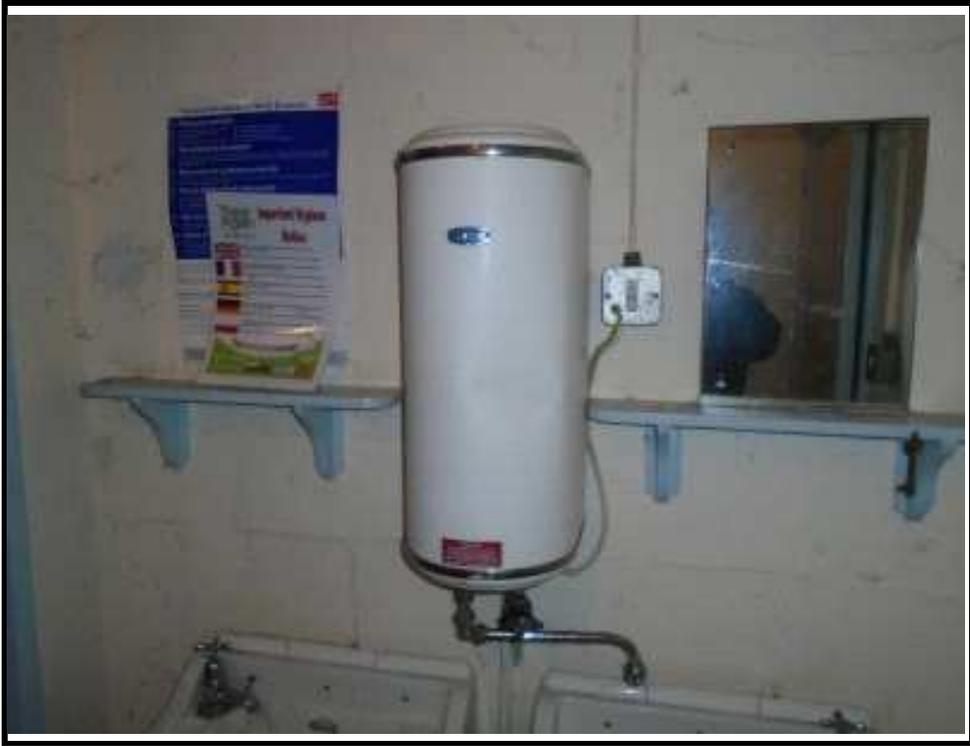
Property Sittingbourne Adult Education	Floor Ground Floor	Incident Number 16122015RCGA034
Room No. / Name Block C - G.004	Location Water Heater	Sample Reference Presumed

Textile Cable Wrap - 1Qty

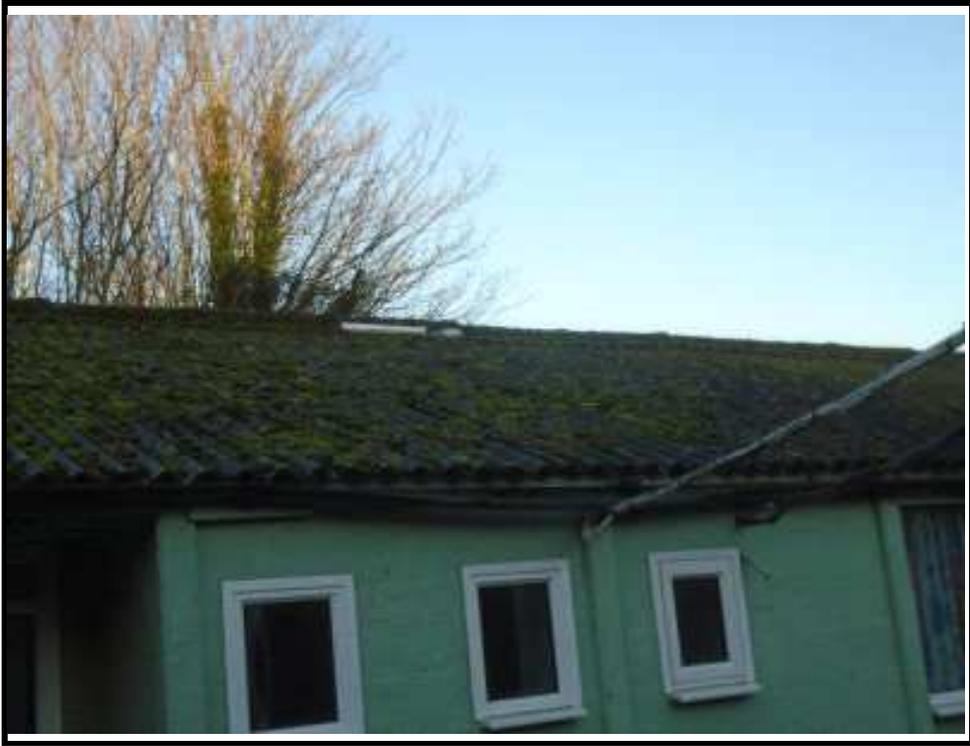
Property Sittingbourne Adult Education	Floor Roof	Incident Number 16122015RCGA035
Room No. / Name Block C	Location Roof Area	Sample Reference A/020/16122015/RCG

Cement Roofing Sheets - 100m2

16122015RCGA035
 Block C
 Roof Area
 Cement Roofing Sheets (100m2)
 Chrysotile – Ongoing safe management of item in situ.

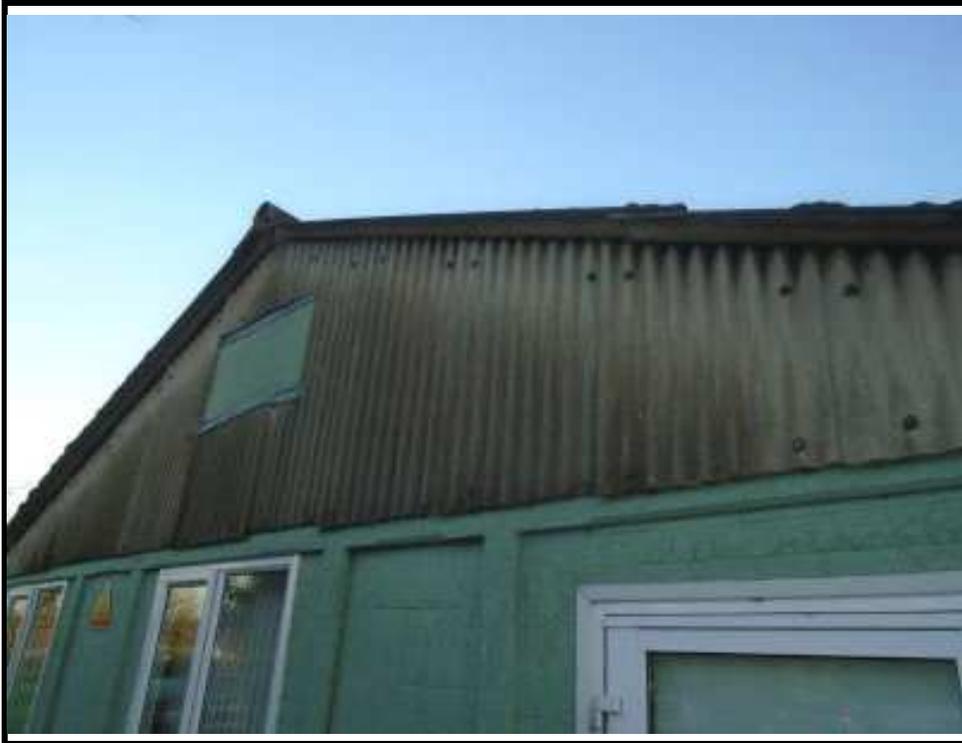
Property Sittingbourne Adult Education	Floor Roof	Incident Number 16122015RCGA036
Room No. / Name Block C	Location Gable Ends	Sample Reference A/021/16122015/RCG

Cement Cladding - 12m2

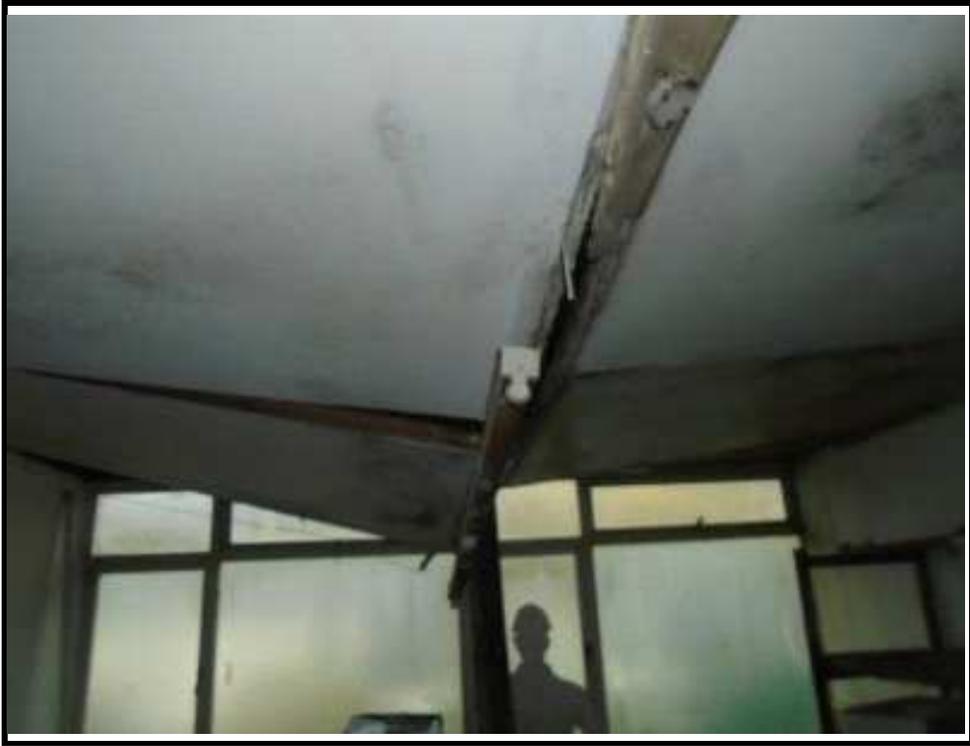
Property Sittingbourne Adult Education	Floor Ground Floor	Incident Number 16122015RCGA037
Room No. / Name Timber Demountable	Location G.001, G.002 & G.003	Sample Reference A/022/16122015/RCG

Insulating Board Ceiling Panels - 45m2

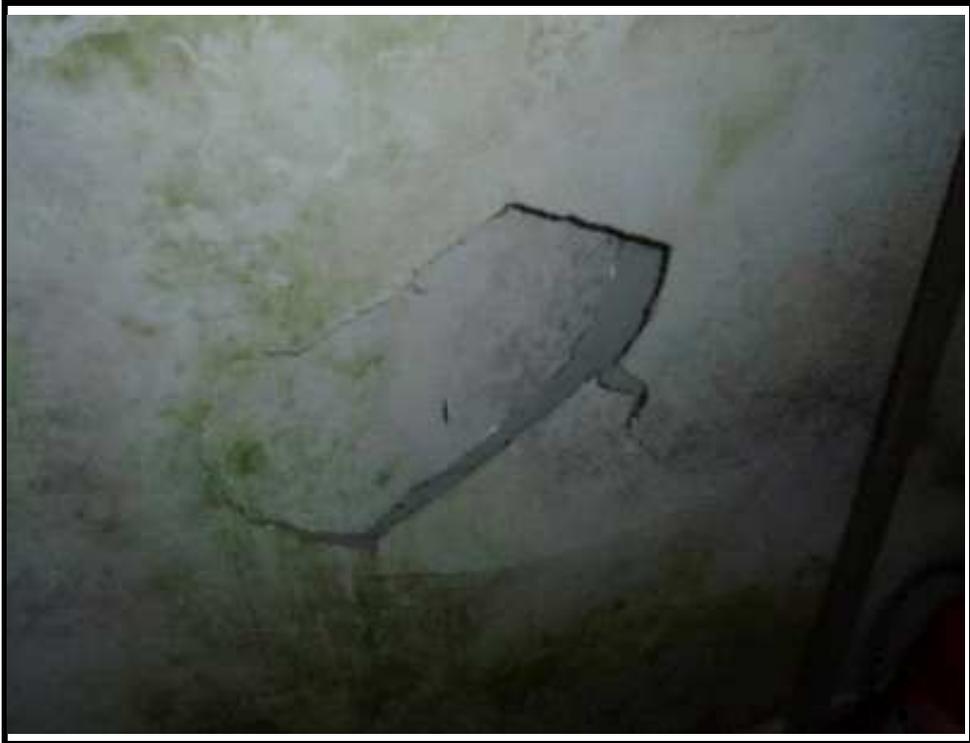
Property Sittingbourne Adult Education	Floor Ground Floor	Incident Number 16122015RCGA038
Room No. / Name Timber Demountable	Location G.001, G.002 & G.003	Sample Reference A/023/16122015/RCG

Insulating Board Wall Panels - 60m2

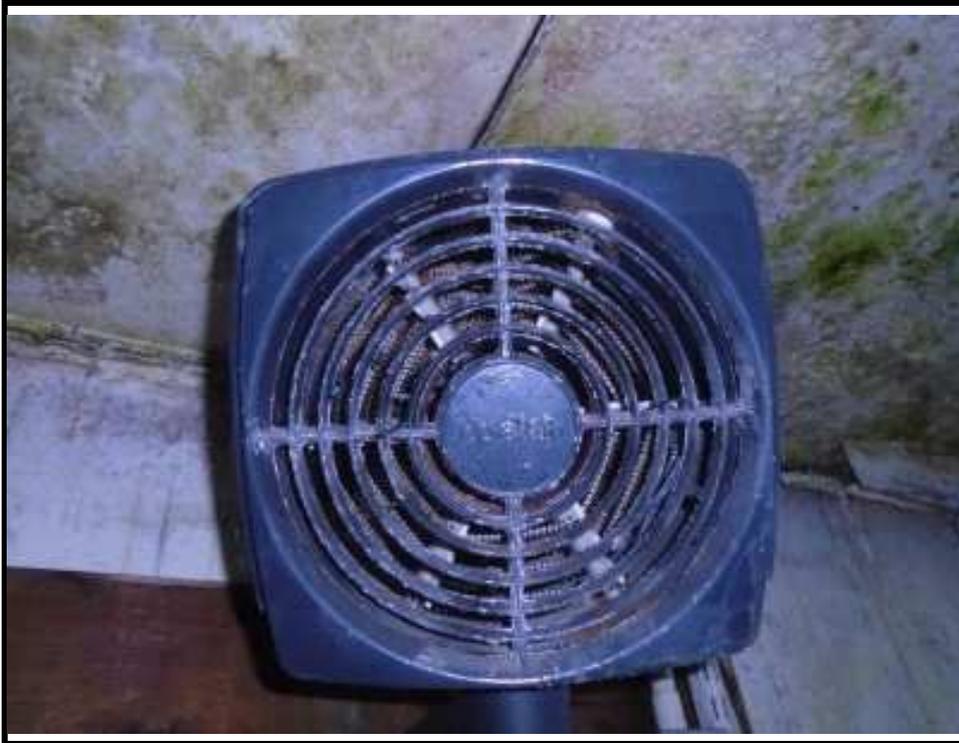
Property Sittingbourne Adult Education	Floor Ground Floor	Incident Number 16122015RCGA039
Room No. / Name Timber Demountable - G.003	Location Fan Heaters	Sample Reference Presumed

Composite Heater Element Spacers - 2Qty

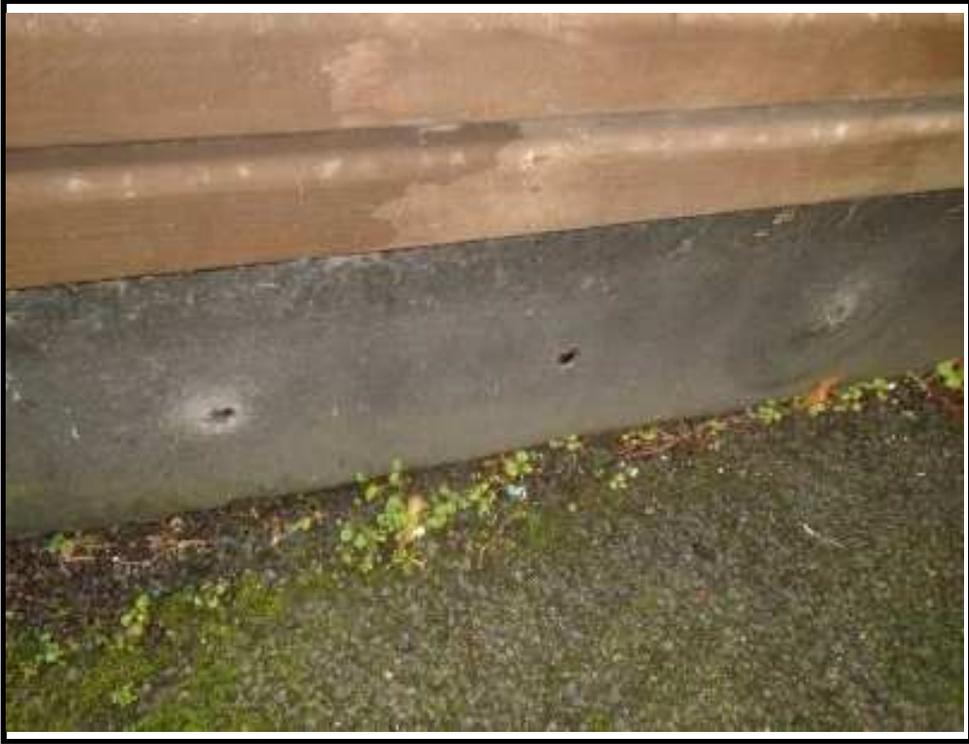
Property Sittingbourne Adult Education	Floor Ground Floor	Incident Number 16122015RCGA040
Room No. / Name Timber Demountable	Location Skirting Panels	Sample Reference A/024/16122015/RCG

Cement Boards - 14m2

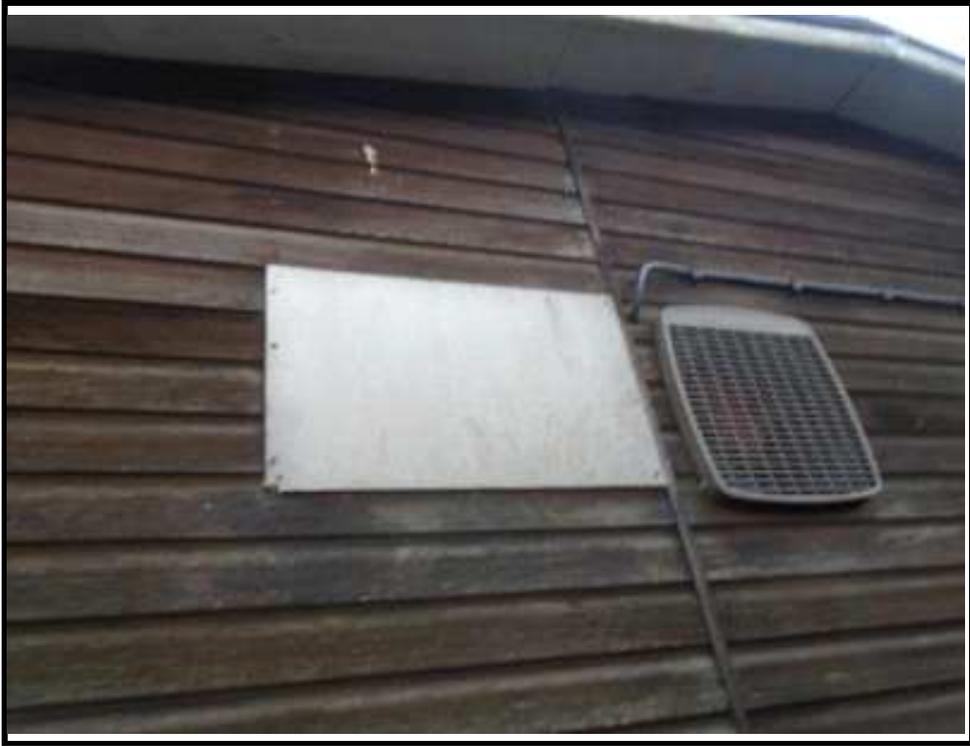
Property Sittingbourne Adult Education	Floor Ground Floor	Incident Number 16122015RCGA041
Room No. / Name Timber Demountable	Location Wall	Sample Reference A/025/16122015/RCG

Insulating Board Panel - 0.25m2

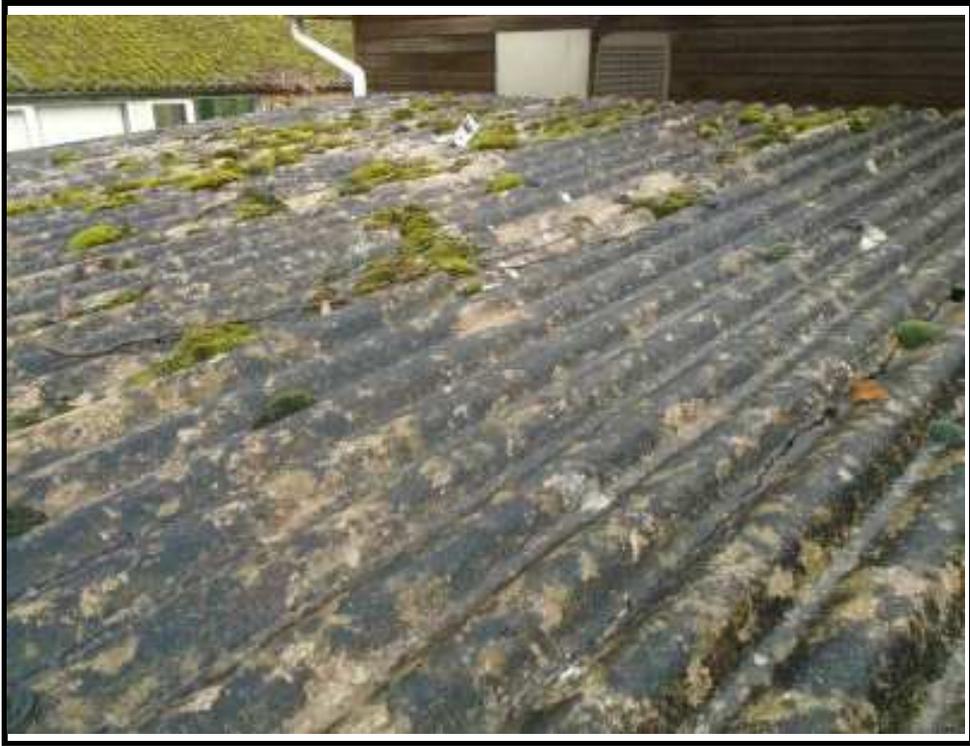
Property Sittingbourne Adult Education	Floor Roof	Incident Number 16122015RCGA042
Room No. / Name Store	Location Roof Area	Sample Reference A/026/16122015/RCG

Cement Panels - 6m2

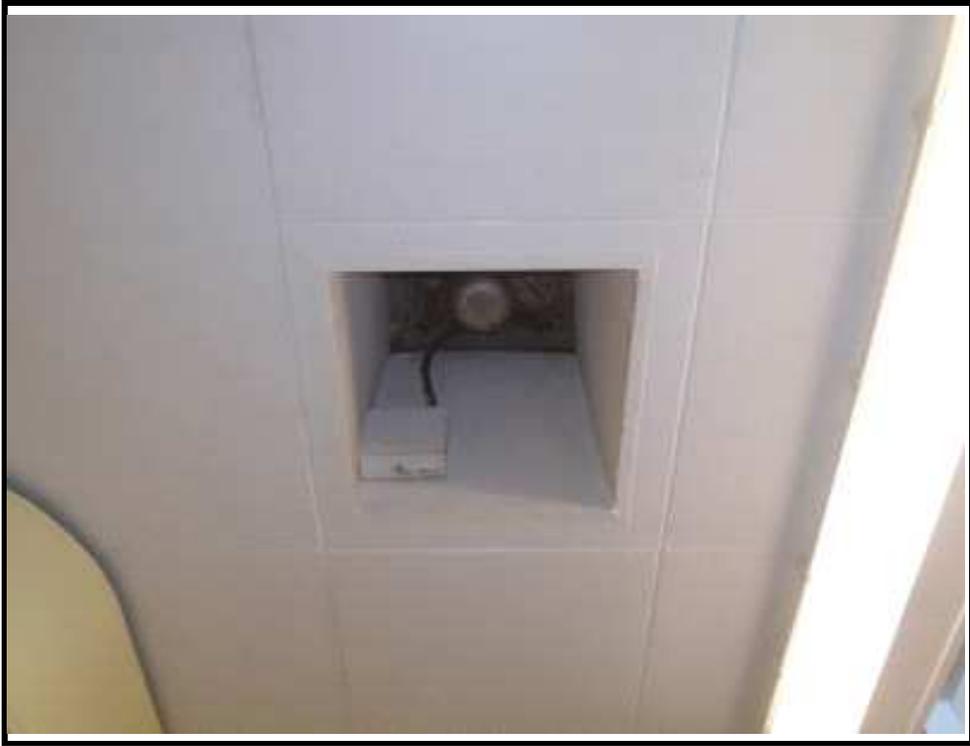
Property Sittingbourne Adult Education	Floor Ground Floor	Incident Number 16122015RCGA004
Room No. / Name G.024	Location Ceiling Extractor Fan Reveals	Sample Reference N/A

No Access to Ceiling Extractor Fan Reveals -

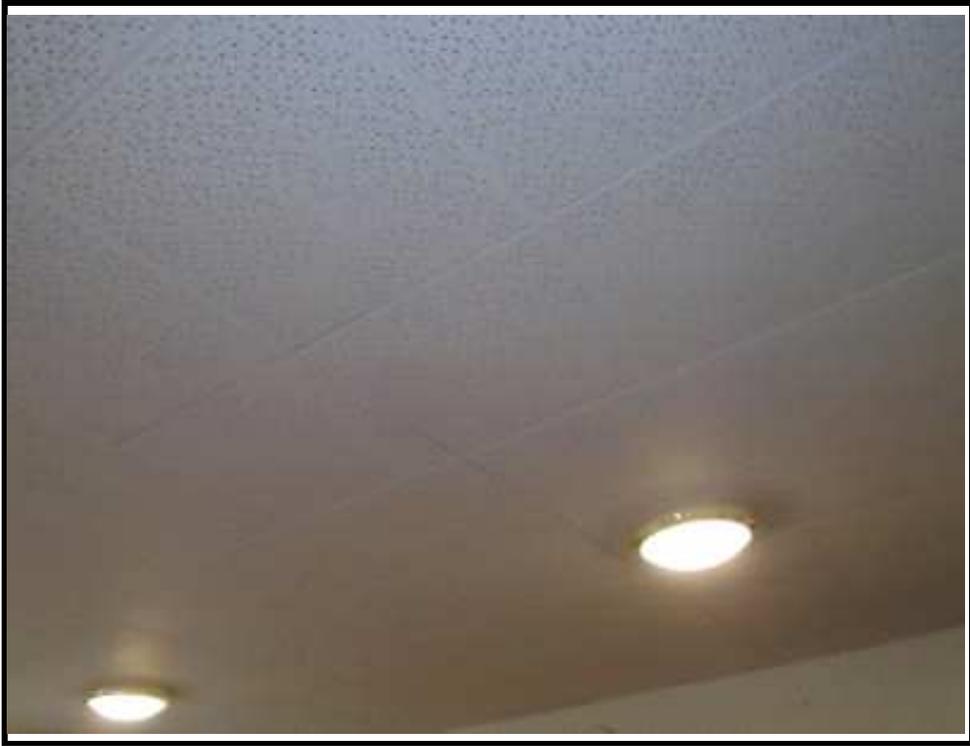
Property Sittingbourne Adult Education	Floor Ground Floor	Incident Number 16122015RCGA027
Room No. / Name Throughout	Location Ceiling Voids	Sample Reference N/A

No Access to Ceiling Voids -

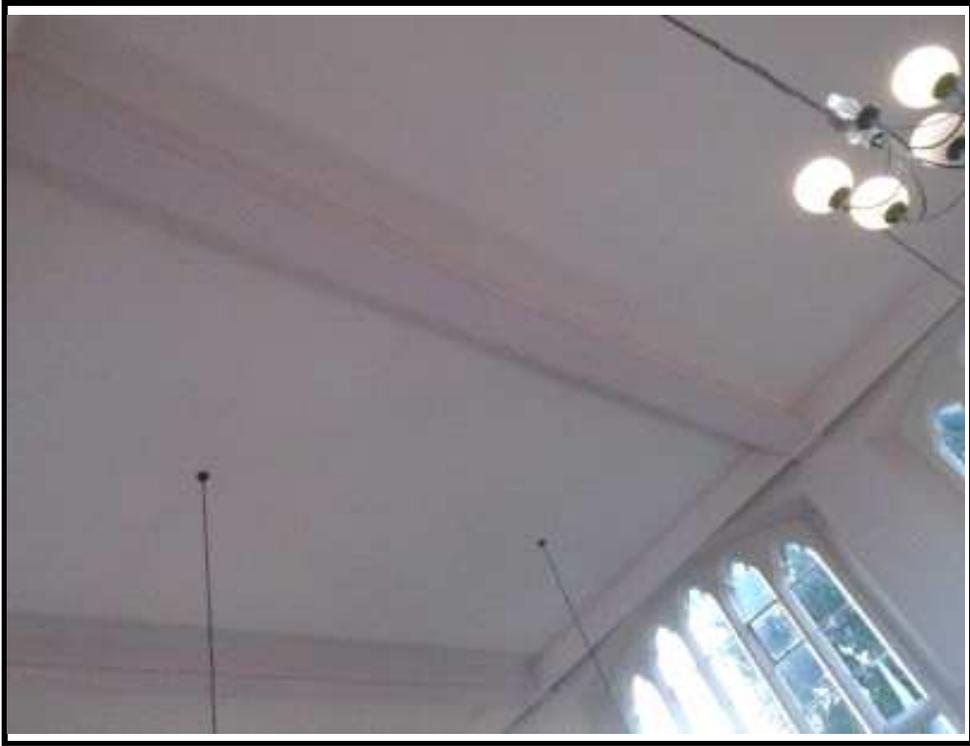
Property Sittingbourne Adult Education	Floor Ground Floor	Incident Number 16122015RCGA028
Room No. / Name G.027	Location High Level Ceiling	Sample Reference N/A

No Access to High Level Ceiling -
