Tree Constraints Preliminary Memo by Tim Moya Associates

Preliminary Feasibility Memo

Project	Sittingbourne Adult Education Ce	entre 171102
Date	3 rd January 2018	
Distribution	Adam Bassi	Gen2
Distribution	Adam Bassi	Gen2

Re: Tree Constraints – Sittingbourne Adult Education Centre

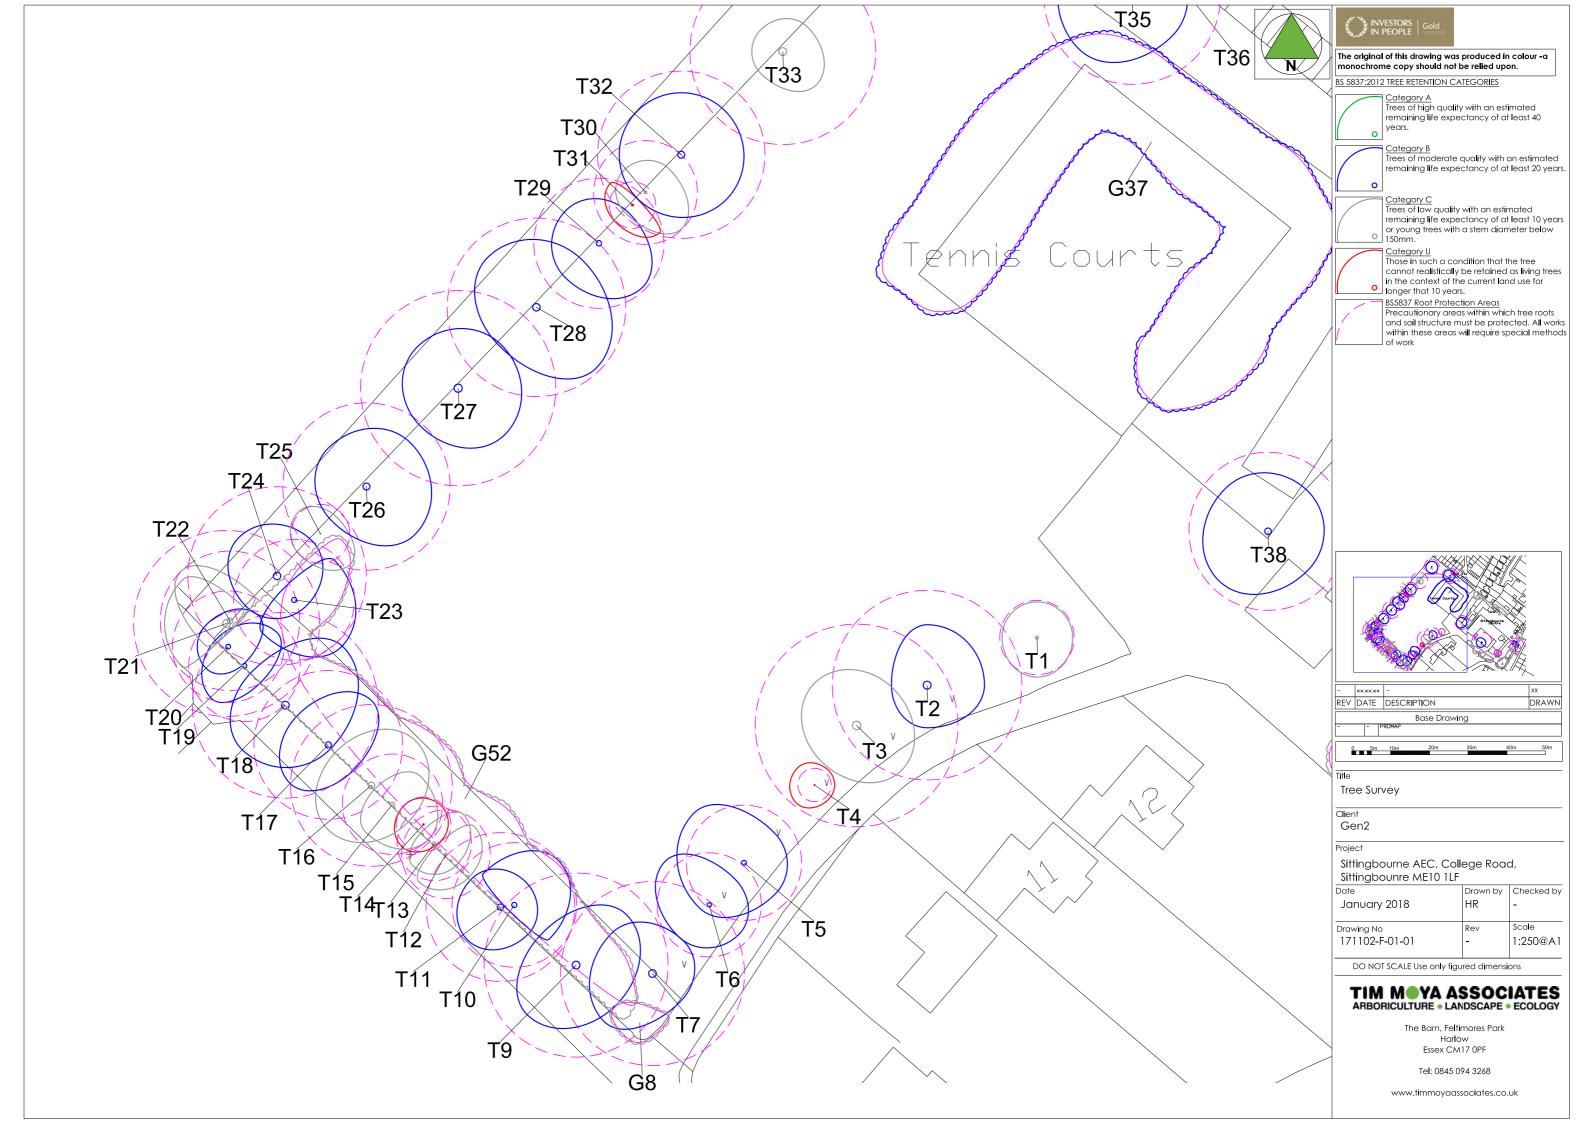
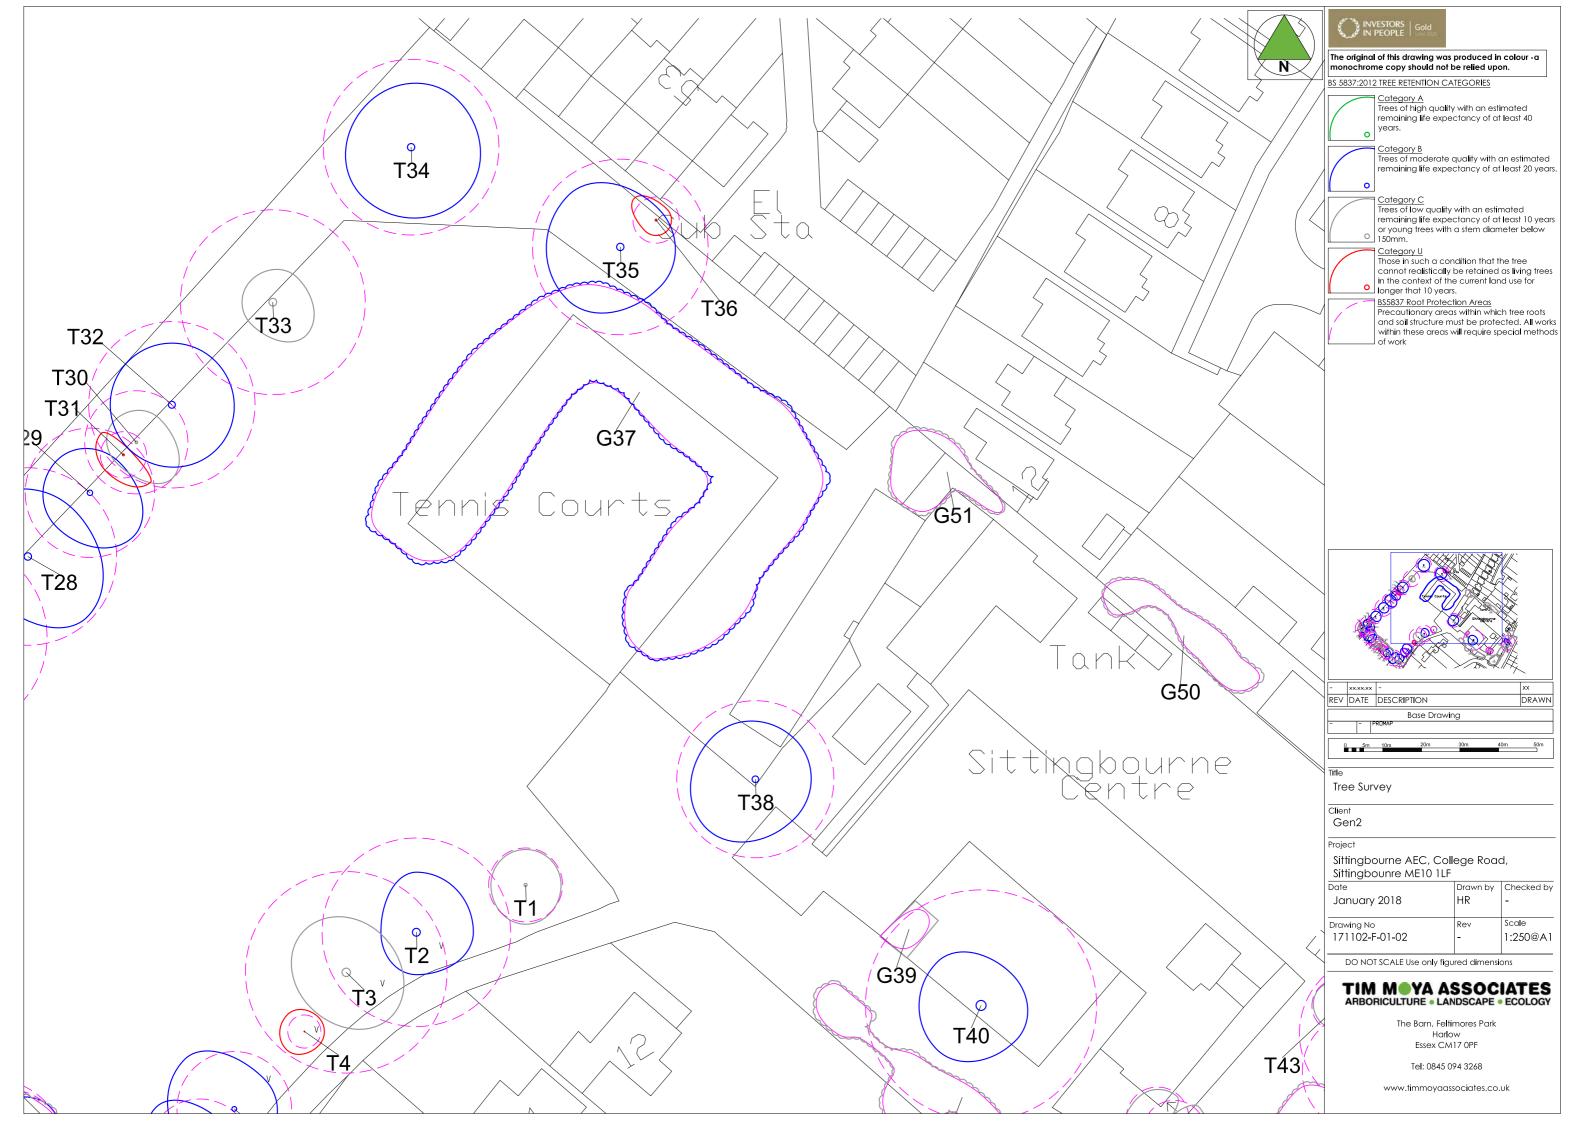
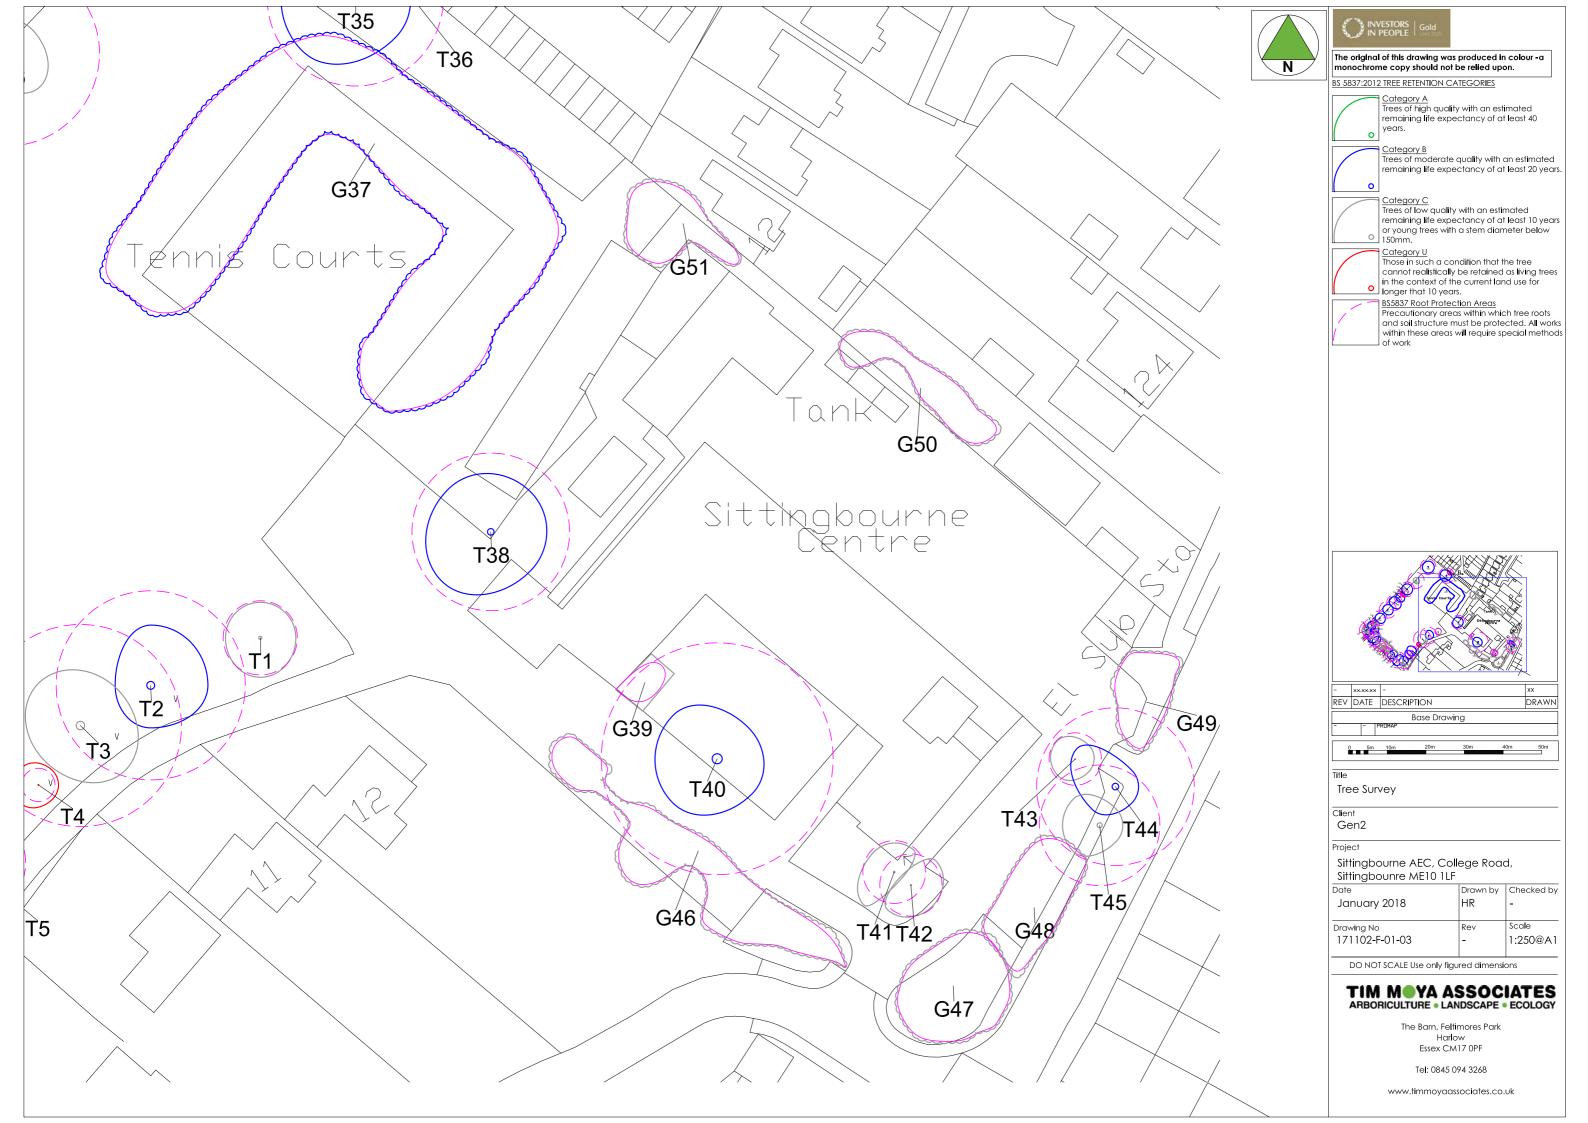
Due to the age and size of the trees, the root protection areas (dashed pink circle denoted on the tree survey plan 171102-F-01 1-3) extend significantly into the site, and will require consideration during design where trees are to be retained.

The tree survey plans attached to this report (reference 171102-F-01-01 to 03) provide indicative tree and tree group locations; with BS 5837: 2012 categorisation, crown spreads and root protection areas. Tree locations have not, however, been taken from a topographical survey. This plan should be used to inform design of the site, avoiding the root protection of significant trees where feasible but will need to be updated when accurate survey information is available. An electronic copy of the drawing has been included with the issue of this report to be incorporated into the architect's design.

The tree survey plan should be read in conjunction with the tree schedule (reference 171102-F-10) included with this report, which provides detail on all the trees surveyed.
