Title: BS5837 Tree Report

Site: The Vicarage

Client: Hill-Wood & Co. (Kent) Limited

Reference: L830AIA

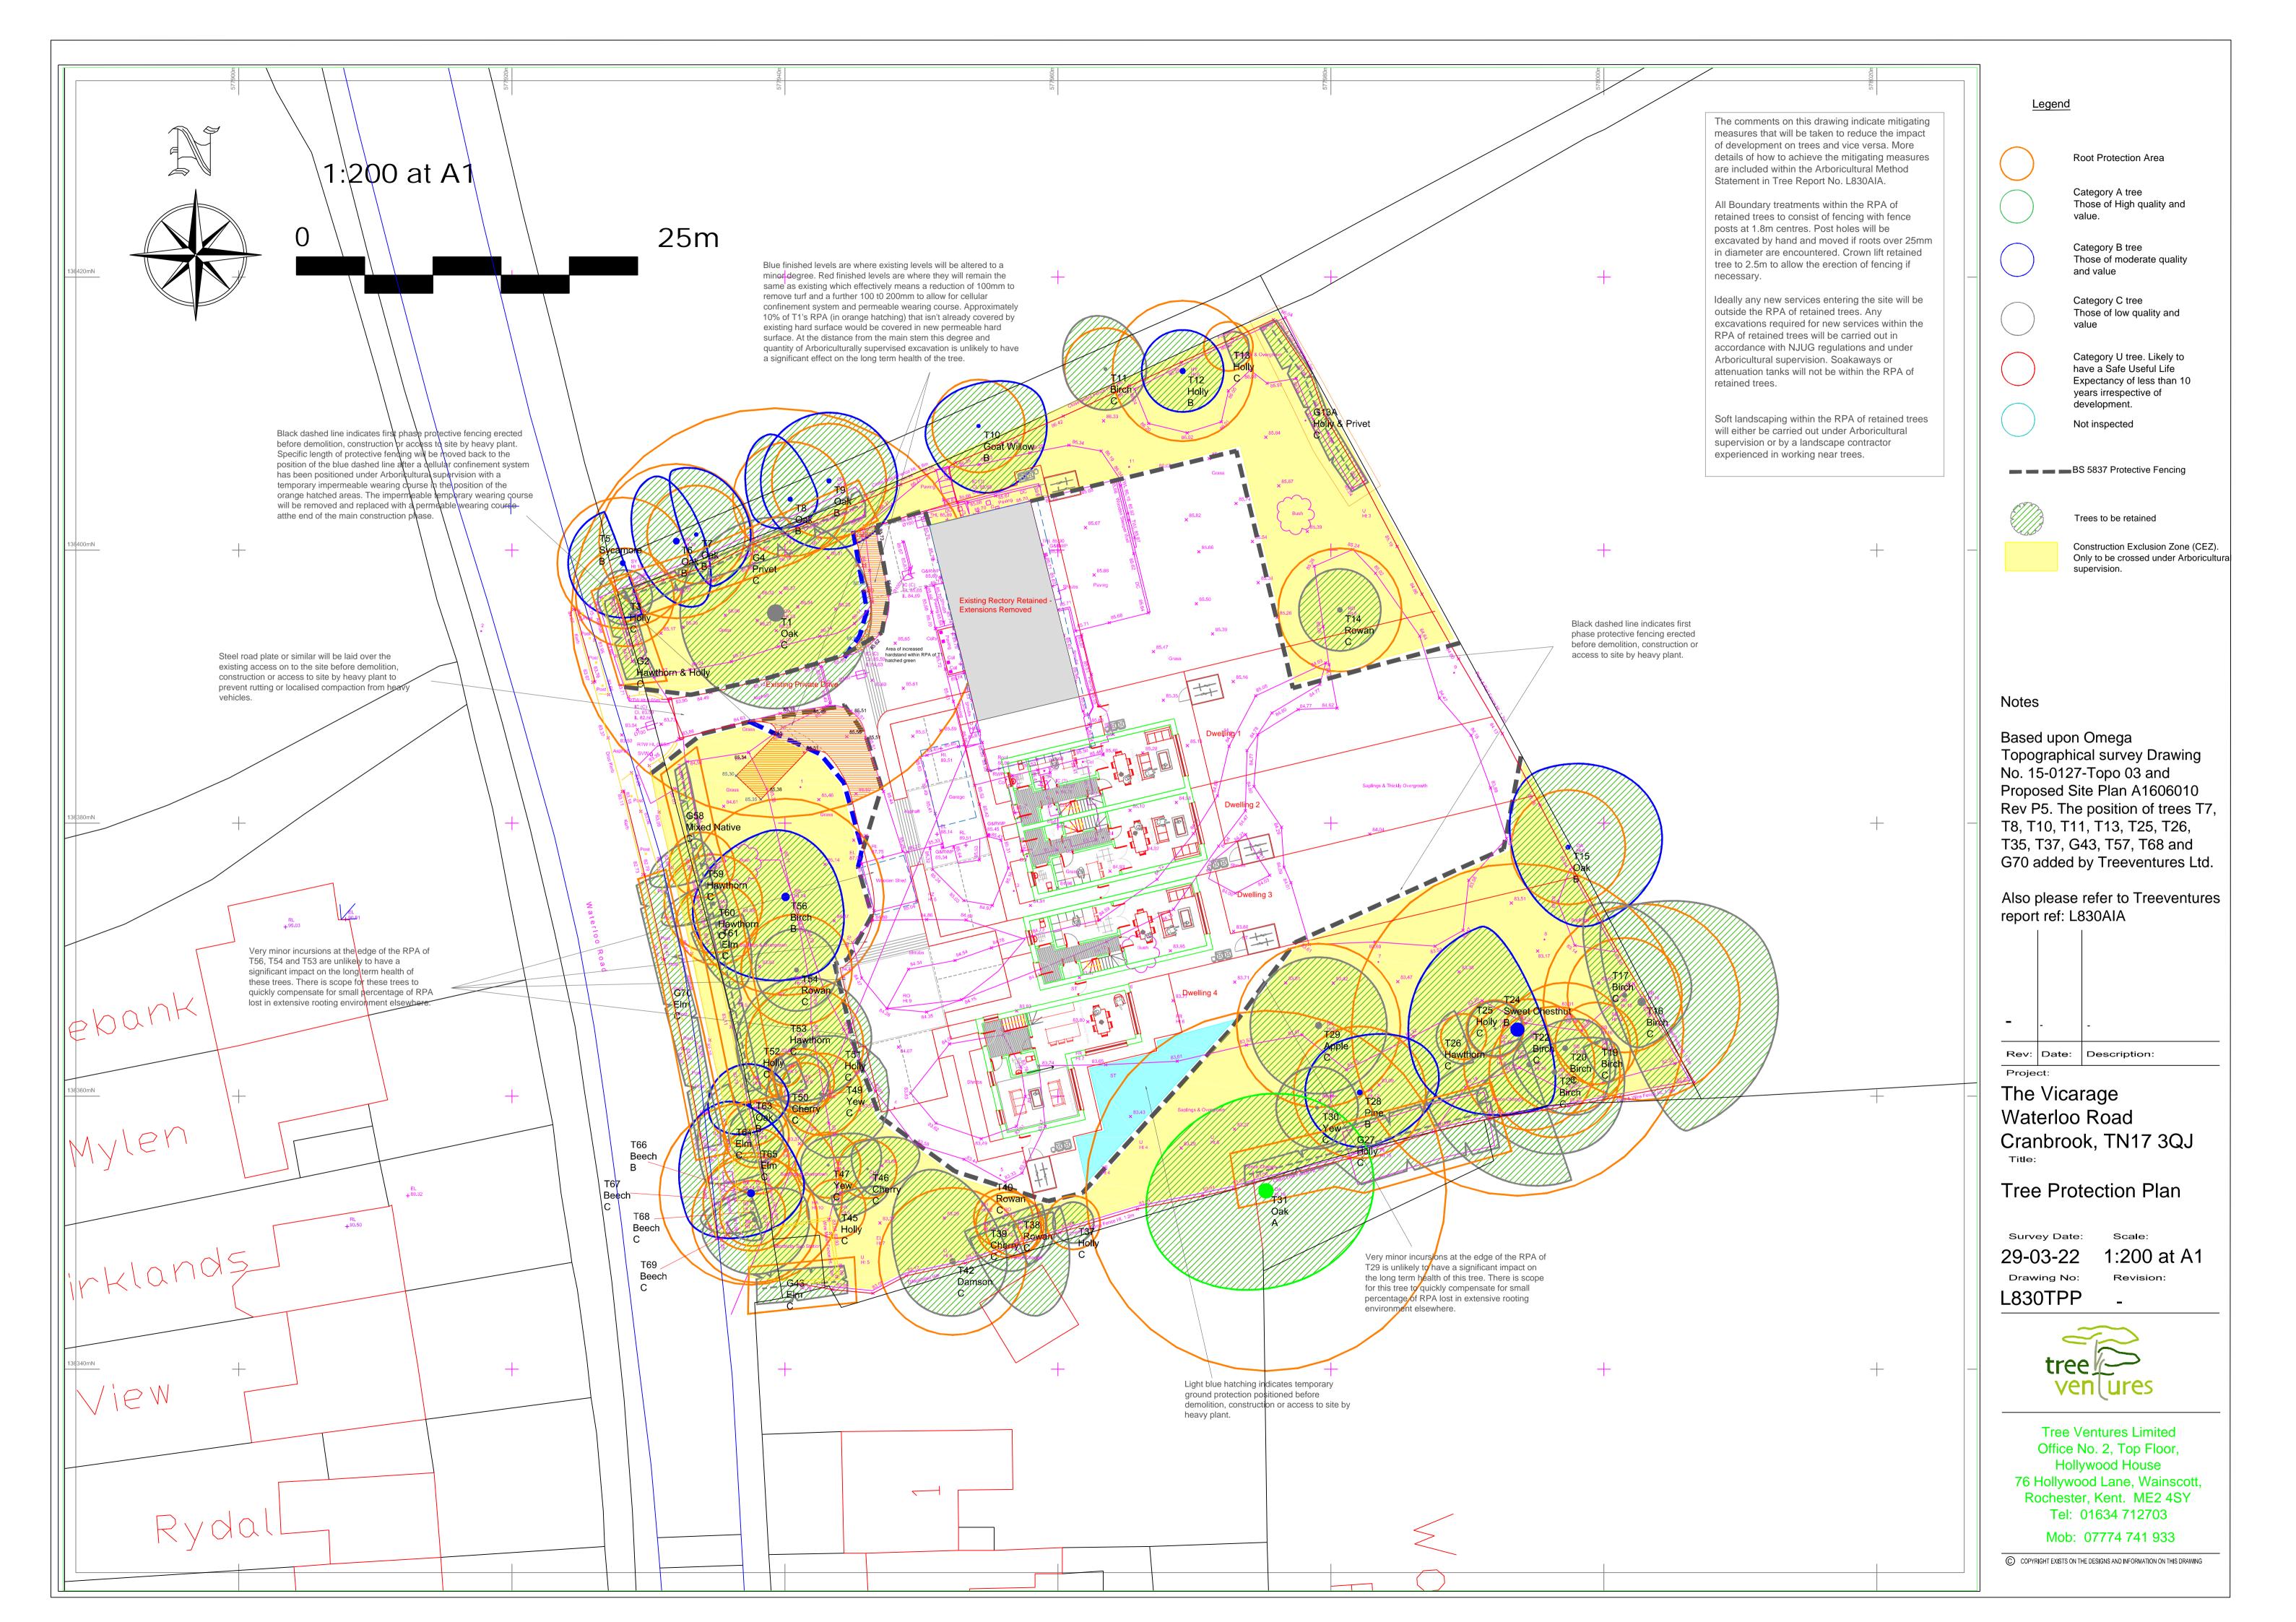
Appendix 7 <u>Tree Protection Plan L830TPP</u>

- 1.2 There will be an impingement on the RPA of 1No. individual C category tree (T1) by the proposed positioning of permeable new hard surfaces and temporary impermeable wearing course as indicated on the Tree Protection Plan (L830TPP) included as Appendix 7. Mitigation: Impingement covers only 10% of RPA that is not already covered in hard surfaces at a reasonable distance from the main stem. Existing and proposed spot levels indicate levels will not require excessive excavation (at the distance from the main stem involved) for new hard surfaces to widen the access drive and create the parking space within the RPA of T1 (Orange hatched area). In addition Arboricultural supervision will ensure the minimum of damage occurs during the installation of the permeable hard surface and temporary impermeable wearing course. The temporary impermeable wearing course will be removed and replaced with a permeable wearing course under Arboricultural supervision at the end of the main construction phase.

The specific mitigating measures shown on Tree Protection Plan L830TPP included as Appendix 7 should reduce the risk of damage to an acceptable level. In addition the following general impacts are considered and mitigated accordingly:

The light blue areas indicated on the Tree Protection Plan L830TPP will require temporary ground protection to allow works or storage of materials within the RPA of retained trees. Temporary ground protection will be laid before demolition, construction or access to site by heavy plant. If machinery is required to spread woodchips this will use temporary ground protection already laid to avoid crossing unprotected RPA of trees.

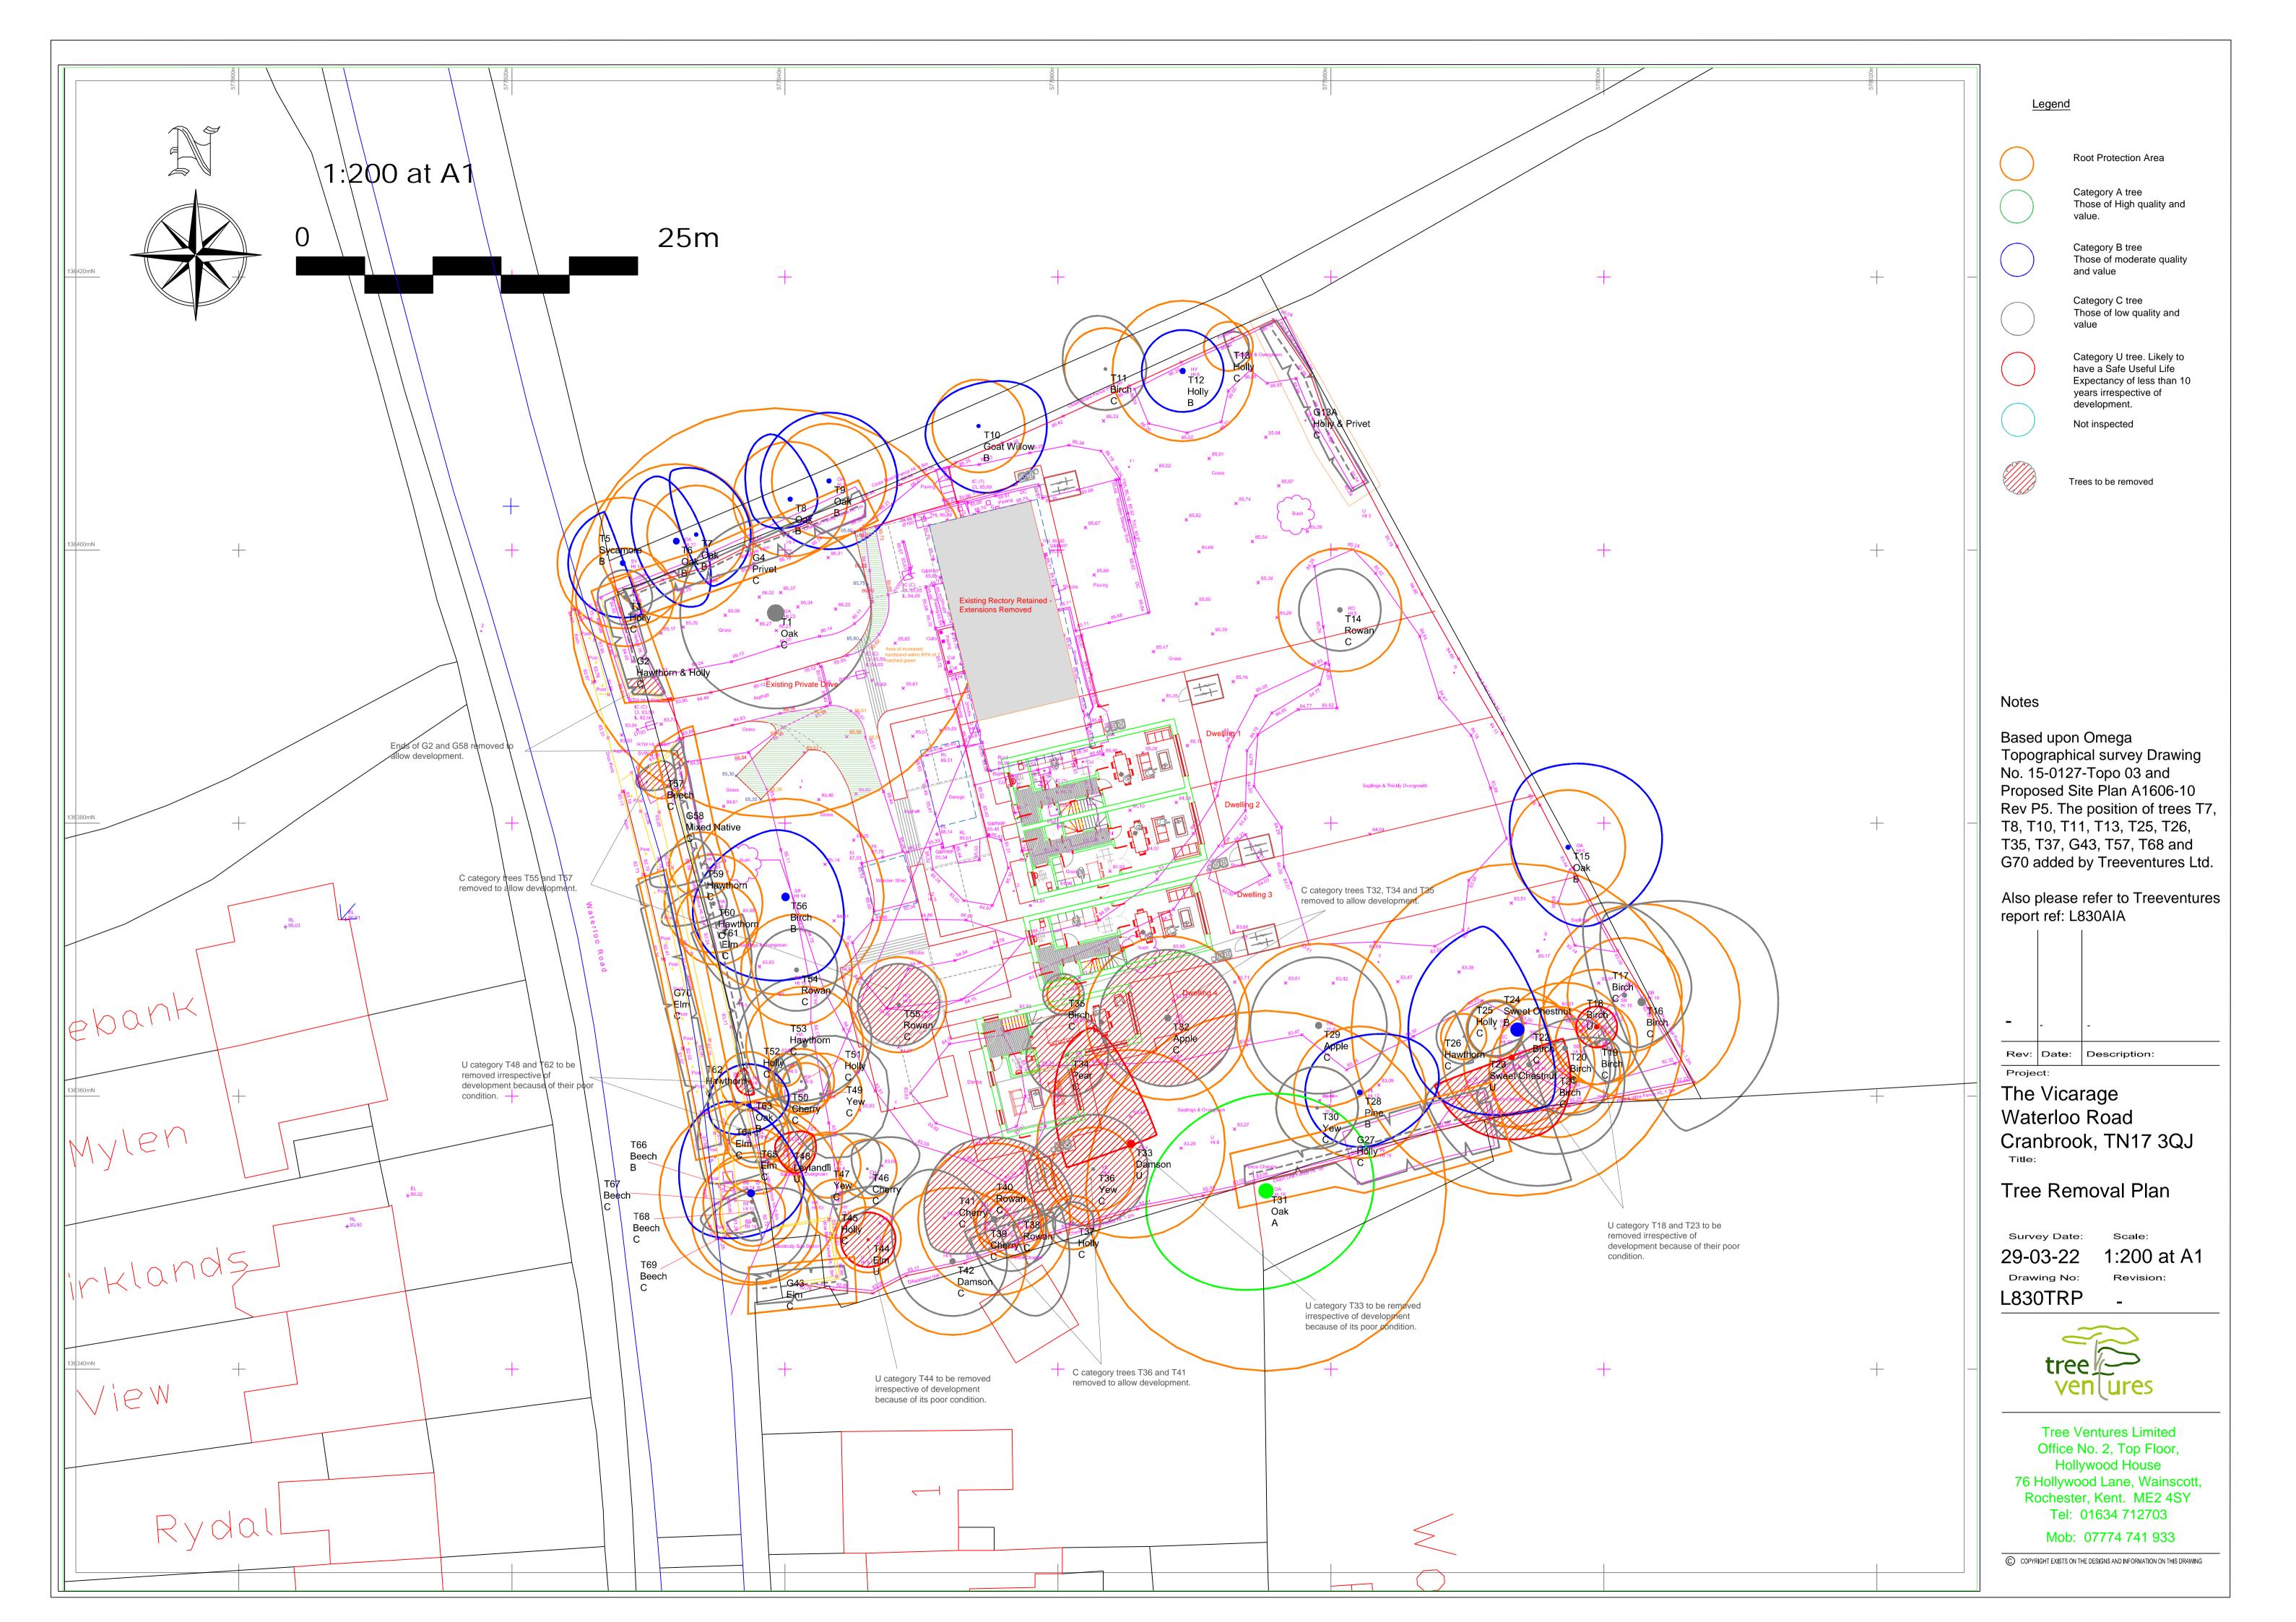
Appendix 8 <u>Tree Removal Plan L830TRP</u>

- 3.2 It will be necessary to remove 7No. C category trees (T32. T34, T35, T36, T41, T55 and T57) to allow the proposed design layout. Mitigation: These trees are not generally significantly visible from outside of the site and their removal is unlikely to detract from the general amenity value of the area. In addition there is scope for replacement planting as part of the landscaping scheme to the rear of the site.

- 3.3 There will be 6 No. U category trees (T18, T23, T33, T44, T48 and T62) removed within the site boundaries. Mitigation: Due to their poor quality or the damage they are likely to cause in the next ten years these trees are likely to have been removed irrespective of development.
