Asbestos Management Survey Report:

Sittingbourne Adult Education Centre
College Road
Sittingbourne
Kent
ME10 1LF
United Kingdom

Date of survey:	Wednesday 16 th December 2015
Surveyors Name:	Robert Grover
Analyst / Quality Manager Name:	Phil Ogden
Signature:

Client:	Kent County Council Sessions House County Hall Maidstone Kent ME14 1XQ
Revision No.	001

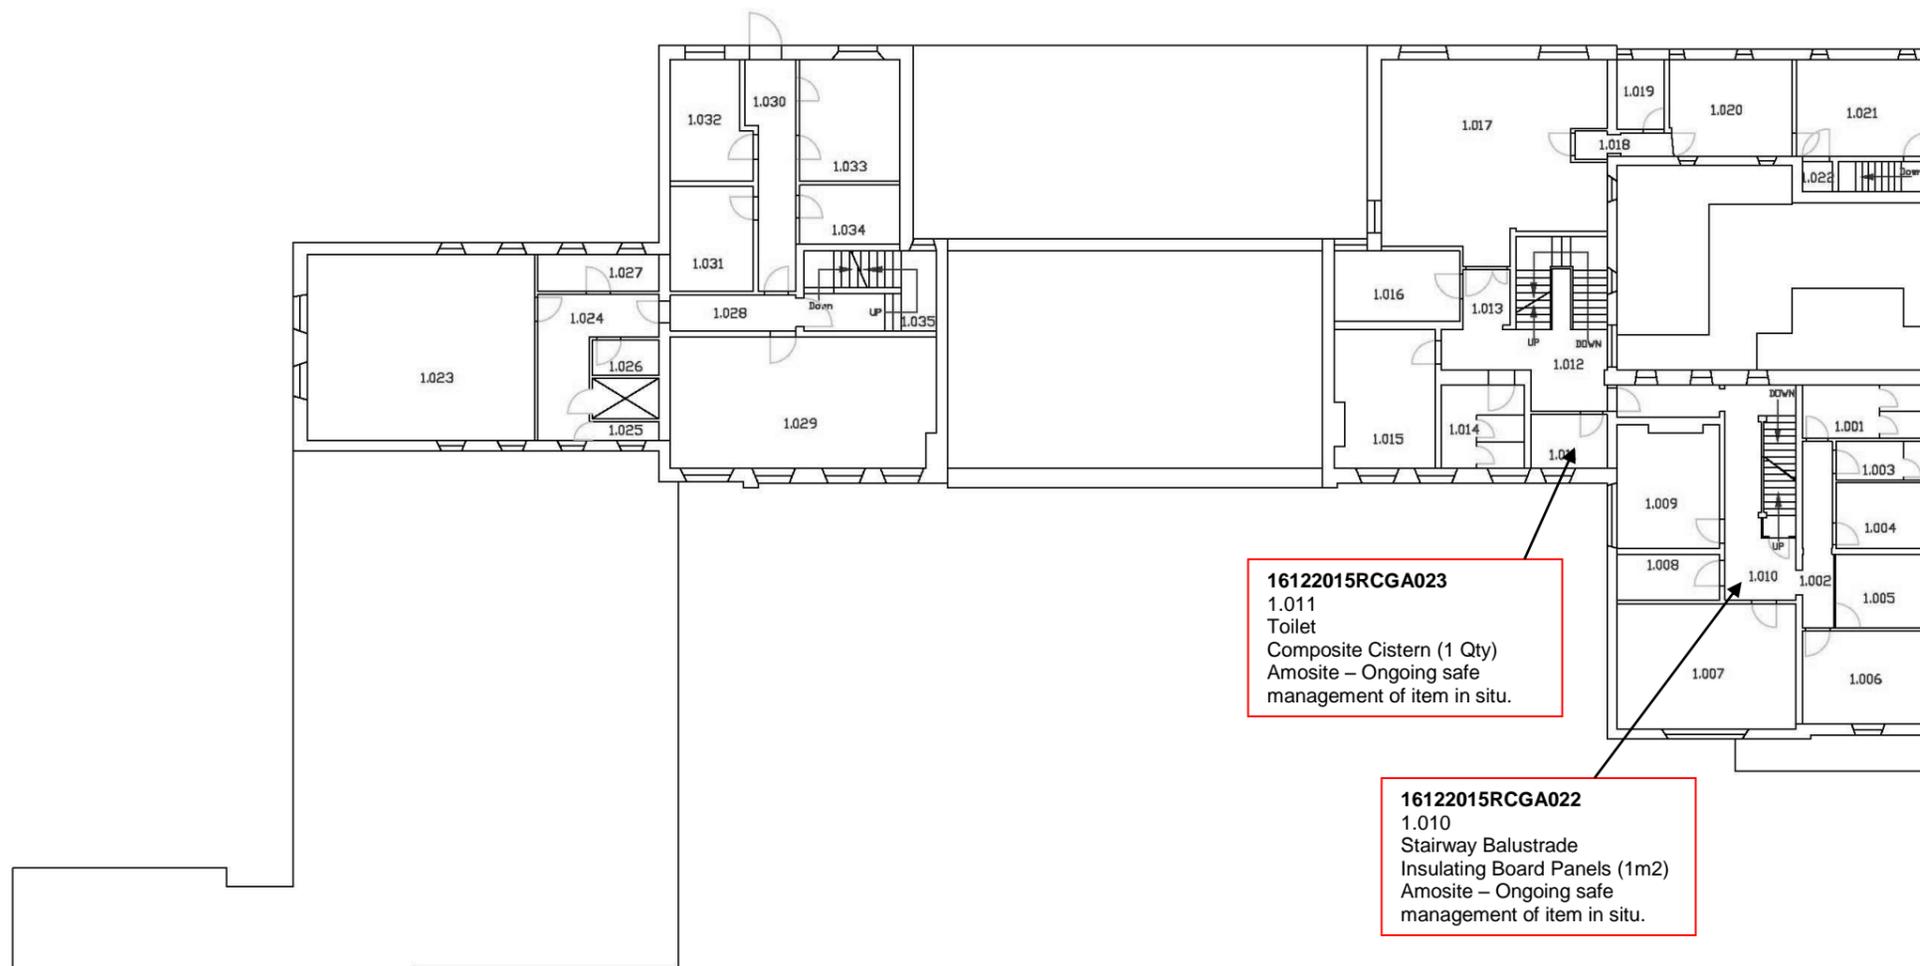
16122015RCGA023
1.011
Toilet
Composite Cistern (1 Qty)
Amosite – Ongoing safe management of item in situ.

16122015RCGA022
1.010
Stairway Balustrade
Insulating Board Panels (1m2)
Amosite – Ongoing safe management of item in situ.

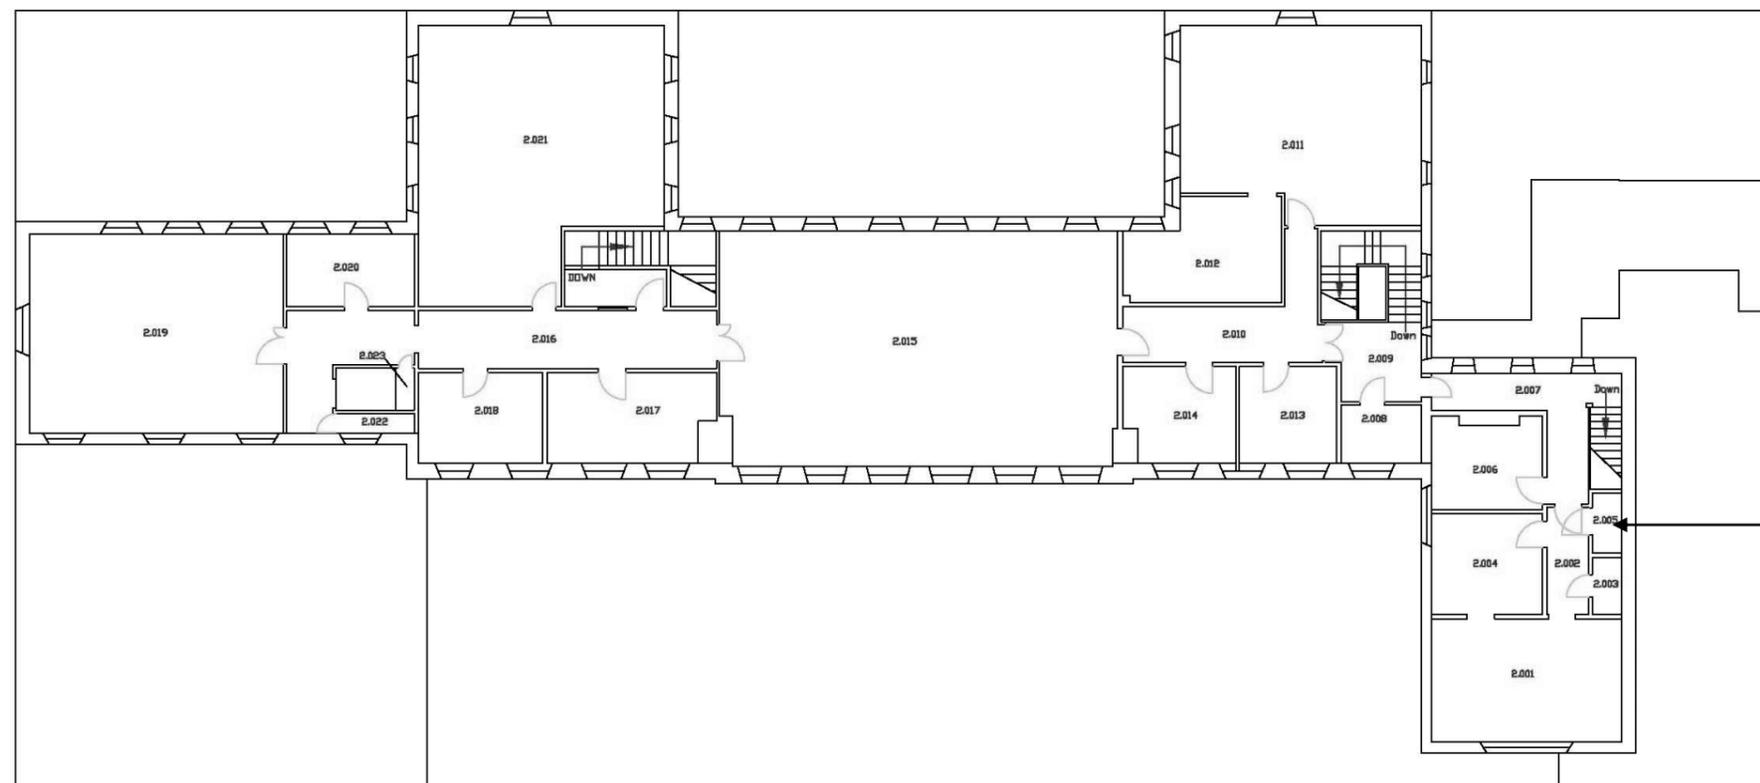
16122015RCGA024
 2.005
 Ceiling
 Insulating Board Panel (0.25m²)
 No asbestos detected. No action required.
